**GOLDEN PLAINS SHIRE COUNCIL**

**LEVEL TWO AND THREE BRIDGE ASSESSMENT REPORT FOR  
FEDERATION BRIDGE LOCATED IN INVERLEIGH  
OVER LEIGH RIVER**

**BRIDGE ID: BRG1000283**

Our Reference: 23-0327  
Date: 15 June, 2023

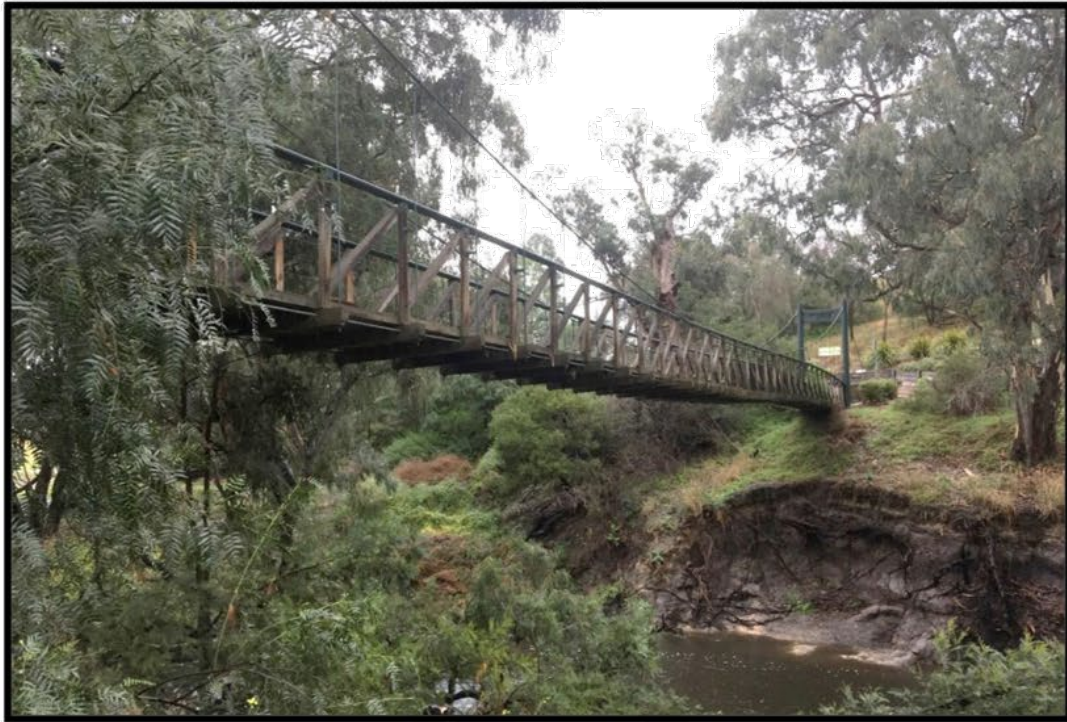
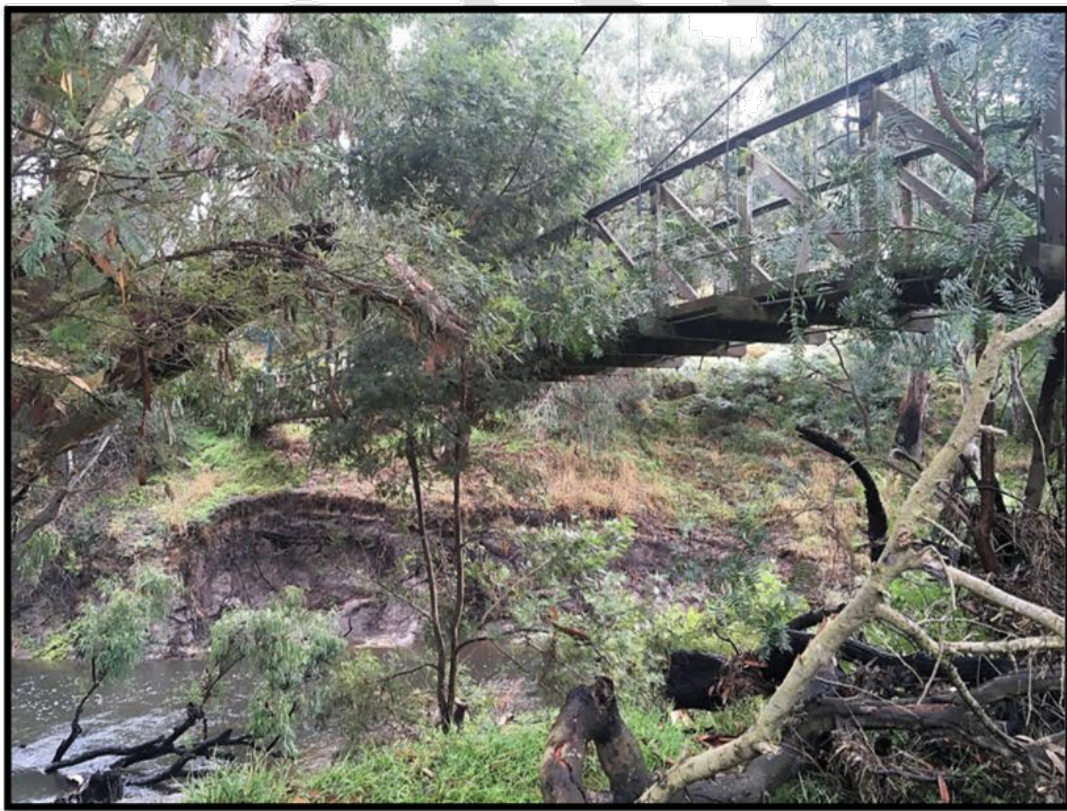
Profile views- note flood debris and vegetation growing next to and through structure- refer above and below

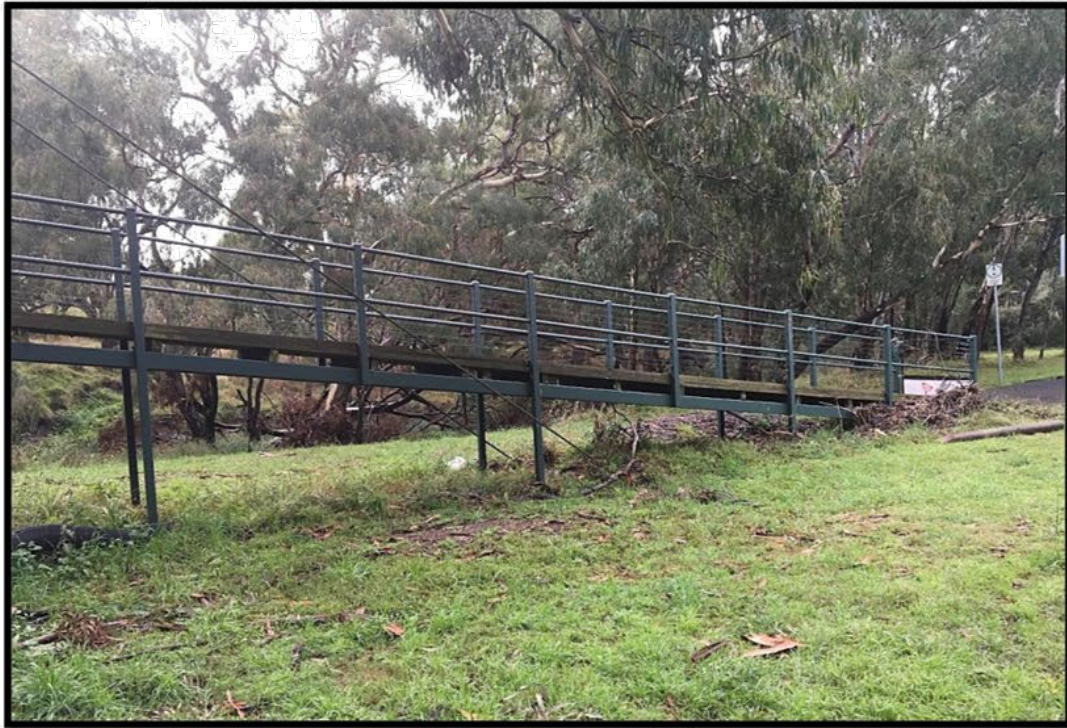
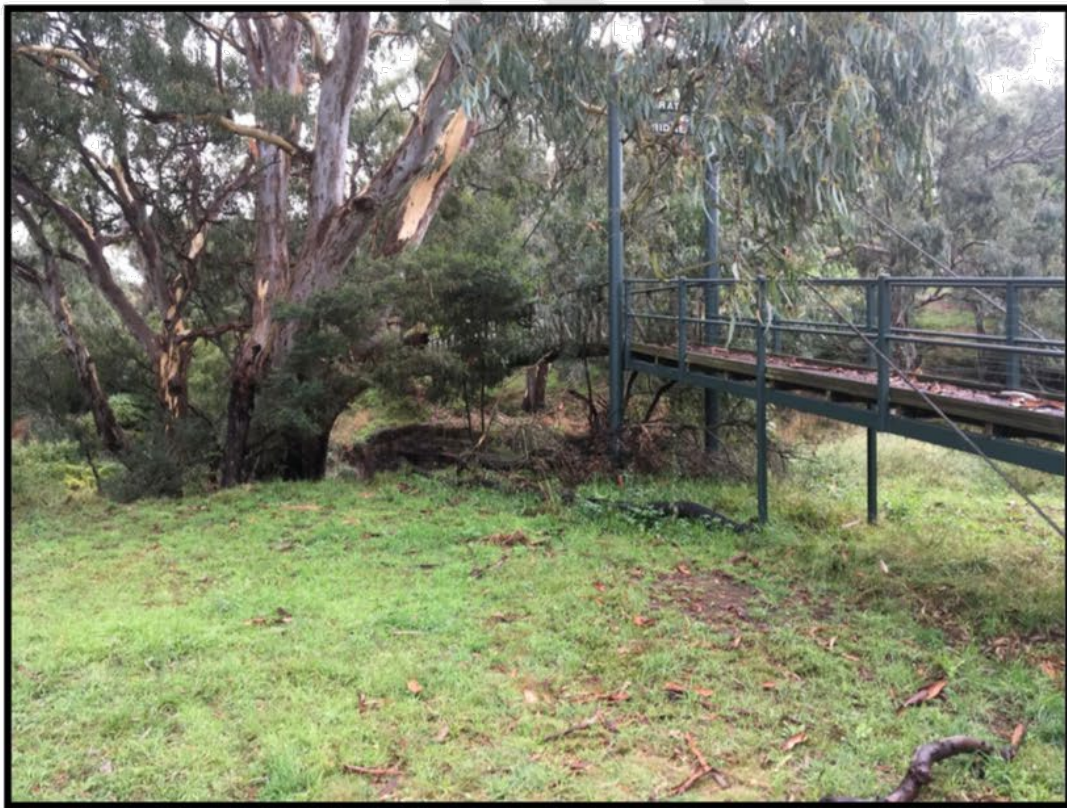
Suspended South walkway- refer above and below

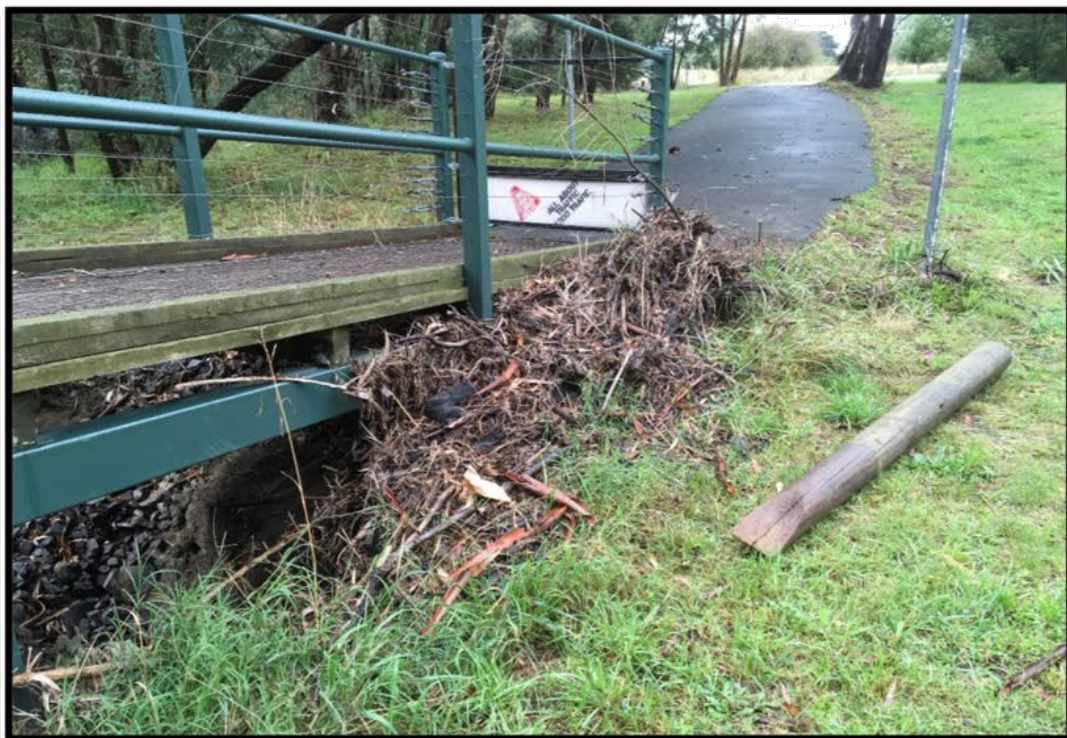
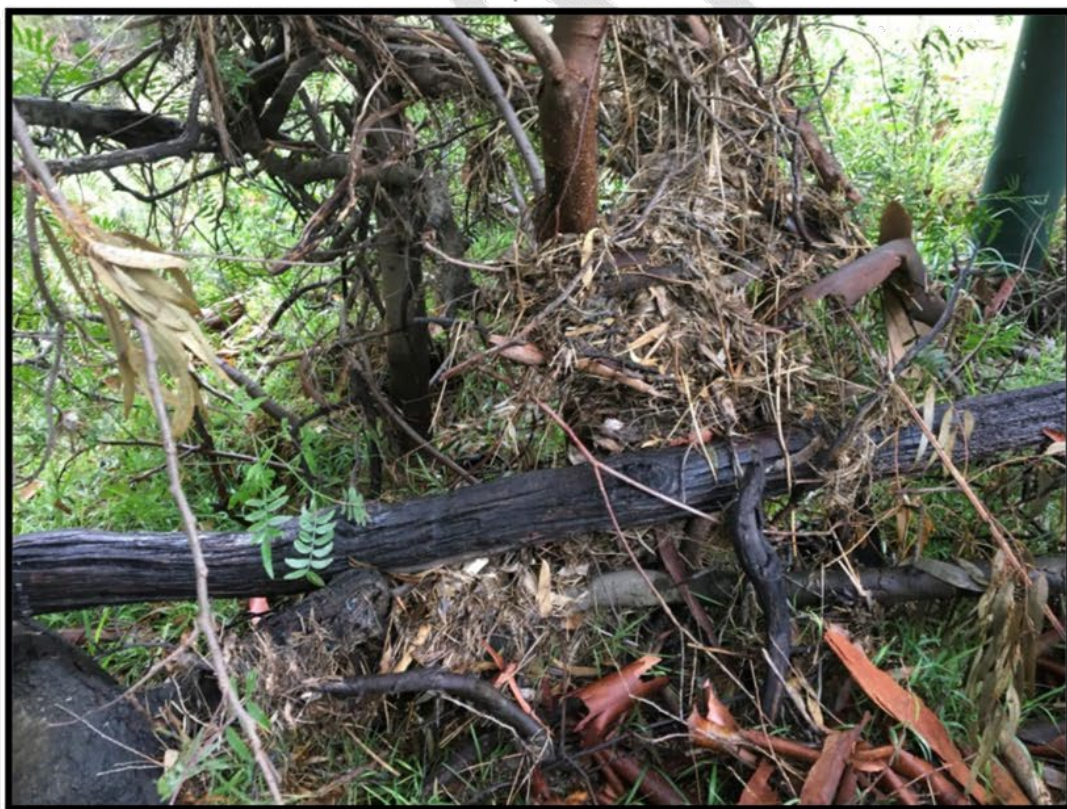
- Flood debris build up at abutments and under structure,
- Scouring at South abutment (and to a lower degree to embankment(s)),
- Creep/ elongation of catenary cables (partial),
- Twist of deck (partial), and
- Loosening/ movement of some fixings/ screws/ bolts,

Flood debris build- up – refer above and below

4.01	Clean and Paint	Deteriorating timber railing and fencing	Clean, treat and paint handrail and approach fencing	1	item	5,860.00	5,860.00	100%	0%	
4.02	Debris	Flood debris build up under and around structure	Clean/remove and legally dispose debris	1	item	1,000.00	1,000.00	0%	100%

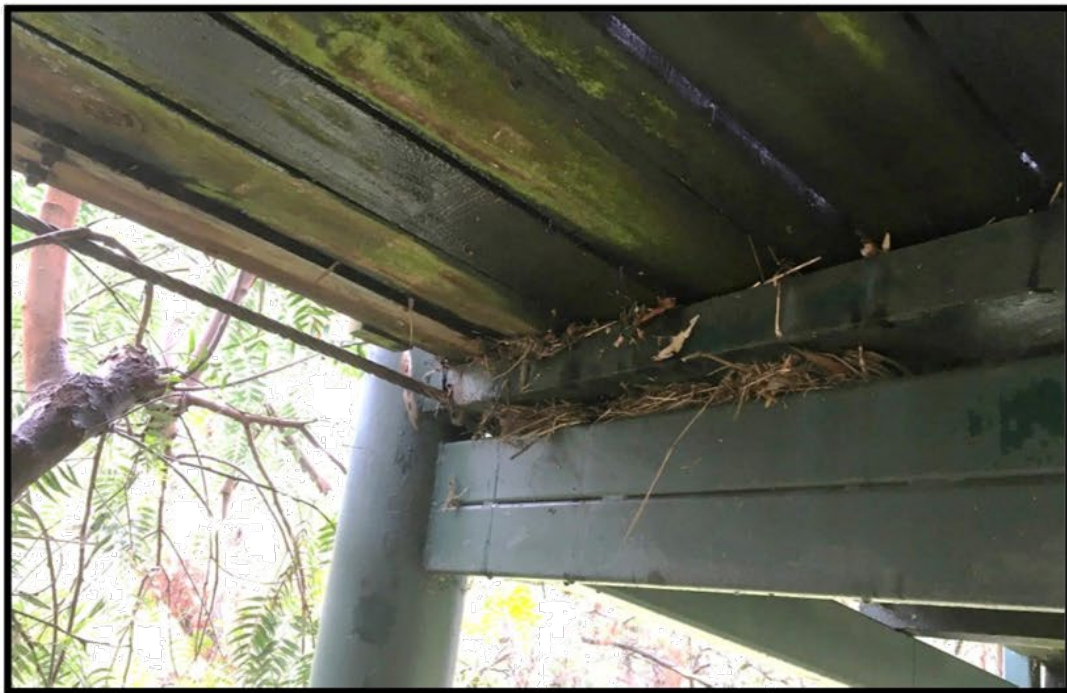
South abutment/ walkway: flood debris caught under deck indicating height of flood waters. Note deterioration and moss/ growth underneath planks.

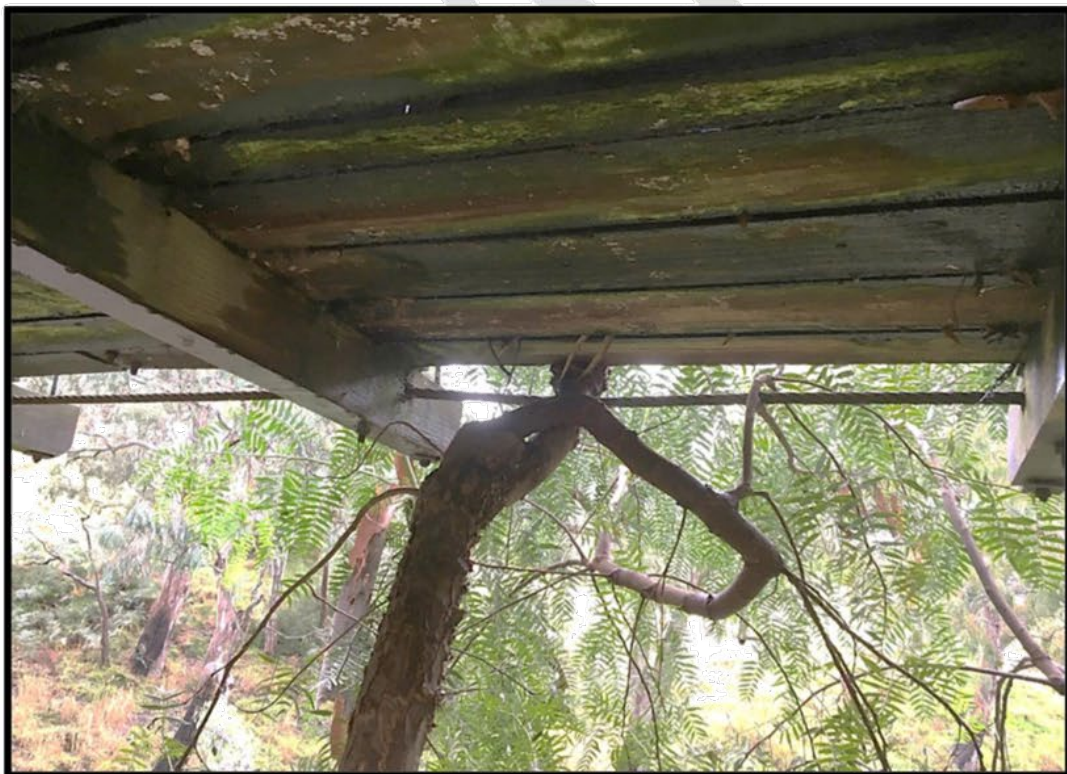
South abutment: tree growing under structure and through cable/ railing. Note deterioration, mould, lichen and moss underneath timber planks and beams

4.03	Vegetation	Tree growing under structure at South end	Remove and legally dispose	1	item	280.00	280.00	100%	0%	Disposal costs included in 4.02
4.04		Bushes impeding access at North end	Trim/ clear and legally dispose	1	item	280.00	280.00	100%	0%	Disposal costs included in 4.02
<b>P Provisional</b>										
P.01	Fixings		Replace broken fixings	1	item	500.00	500.00	100%	0%	Notional amount
P.02	Crossbeams/ floor beams		Assess, treat and/ or replace as required	10	lin m	670.00	6,700.00	75%	25%	Assume an extra third require replacing
P.03	Barrier / Guardrail		Replace wire barrier with ARC roll top mesh	70.6	lin m	96.99	6,847.50	100%	0%	
P.04	Design		1 week to verify structure can support roll mesh	1	item	8,000.00	8,000.00	100%	0%

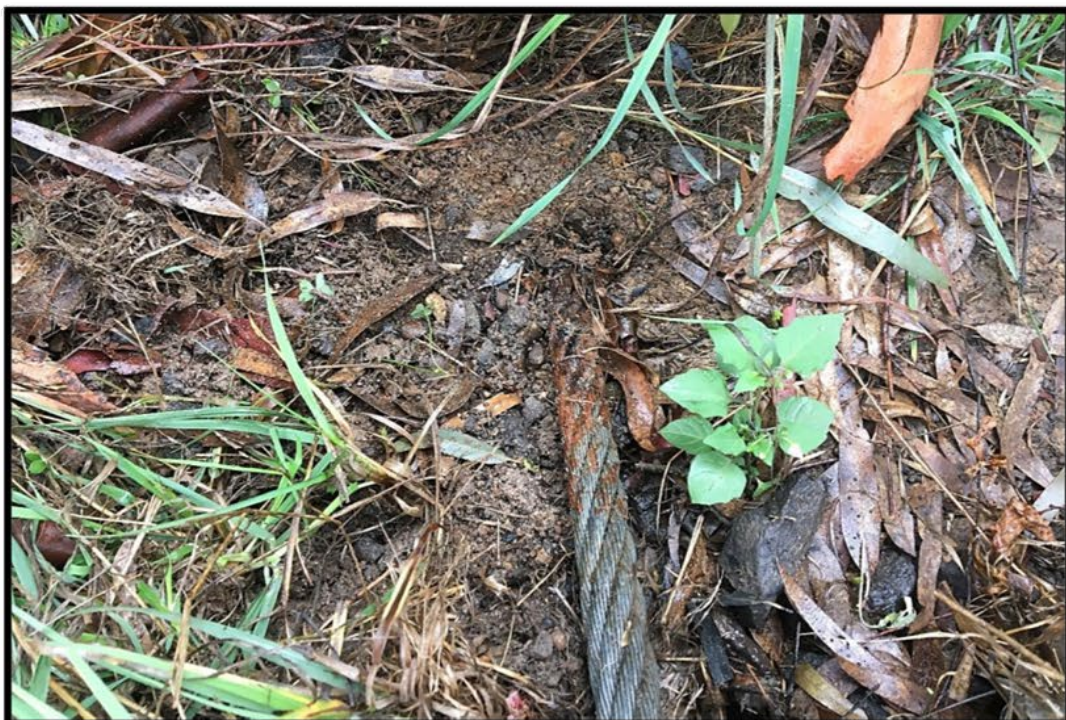
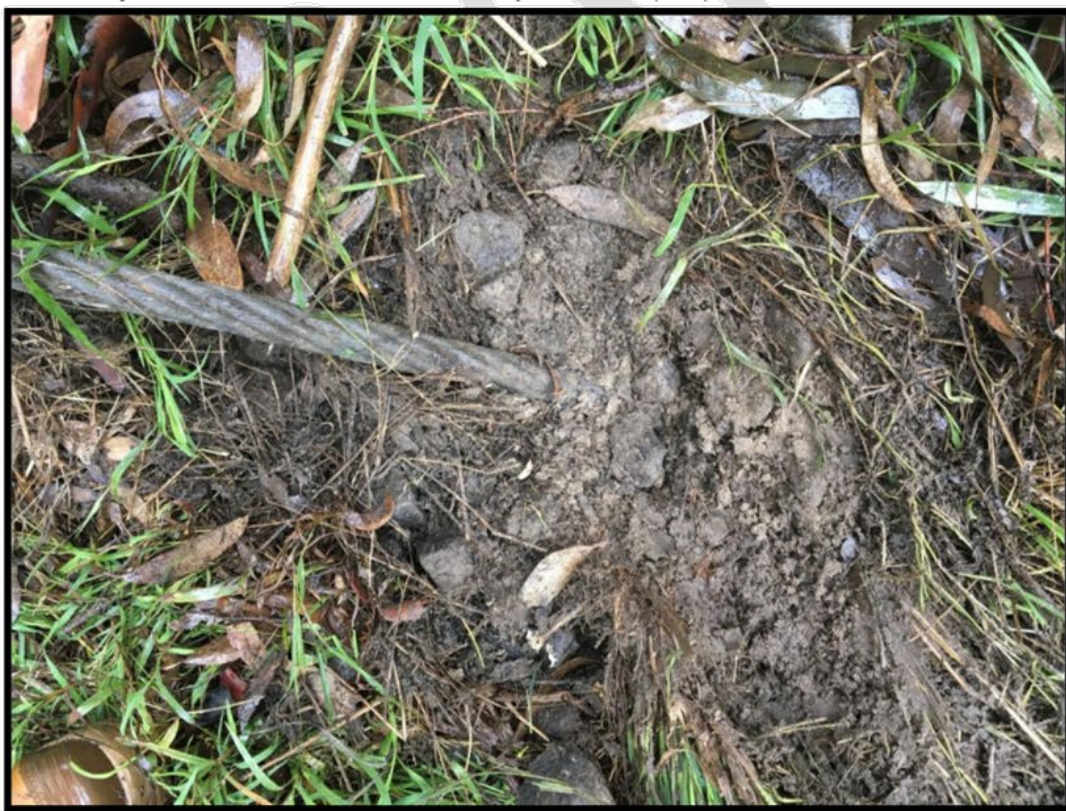
- Cables appear to have been directly embedded into footings and do not present any adjustment mechanism,
- At ground level, cables have been exposed to/ buried into soils and vegetation creating durability concerns evidenced by the presence of rust and corrosion of the cable(s),
- Visibly noticeable cable creep/ elongation, likely as the result of long- term progress,
- Droppers/ suspenders (12mm bars) are missing and/ or damaged in several places,
- Adjustable heads of droppers/ suspenders appear to have previously been treated for corrosion and painted, and
- The towers appear in good condition.

South- Catenary cables assumed to be directly embedded into concrete pad- note absence of adjustment mechanism and durability concerns (rust) - refer above and below

2.07		Cable embedded into concrete footing creating durability/ rusting concerns	Investigate extent of corrosion	N/A				100%	0%	Add to annual asset inspection programme level 2 bridge inspections

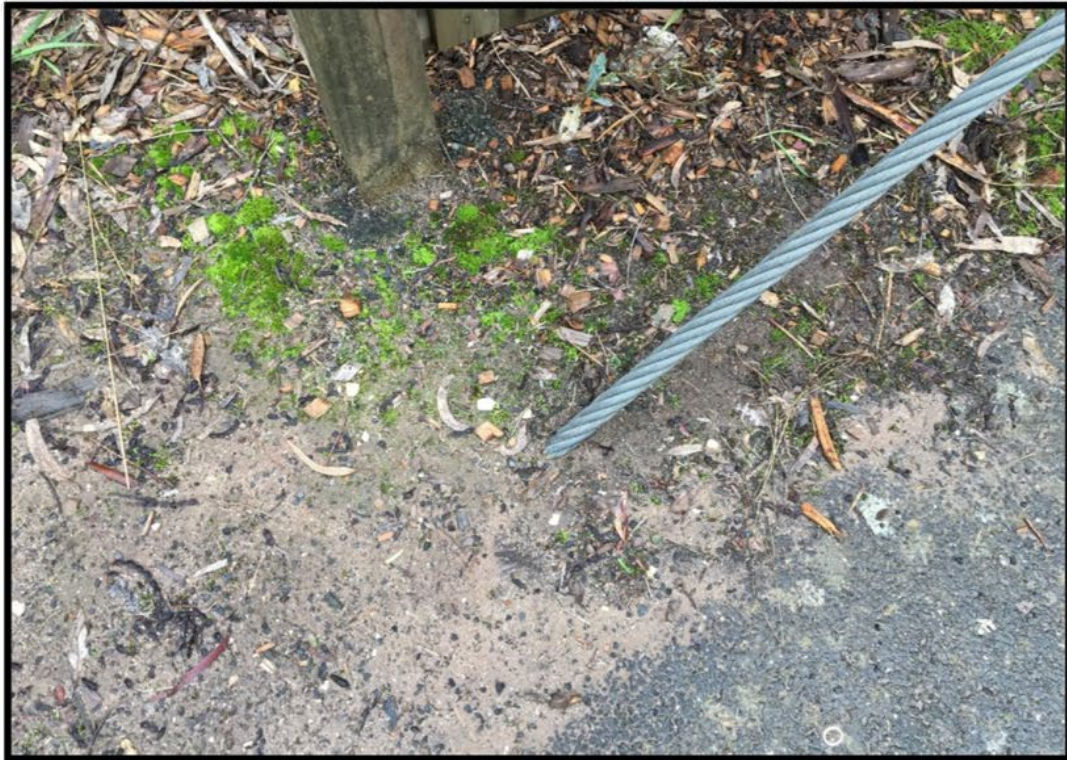
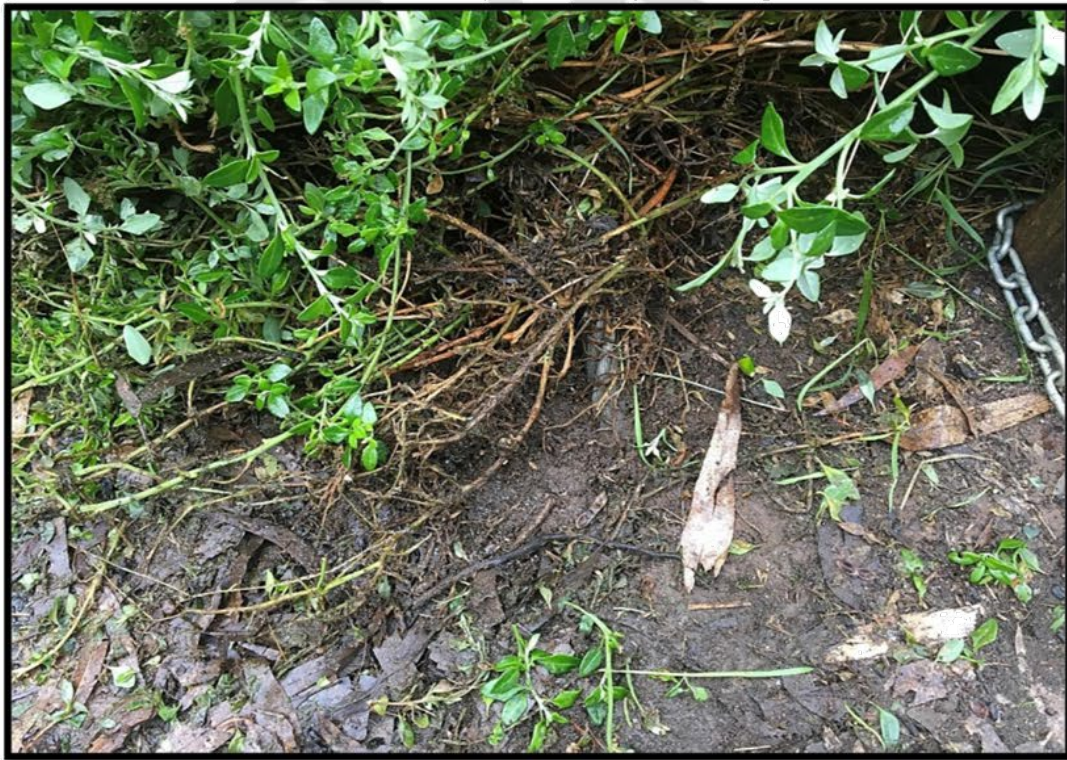
North- Catenary cables assumed to be directly embedded into concrete pad- note absence of adjustment mechanism and durability concerns - refer above and below

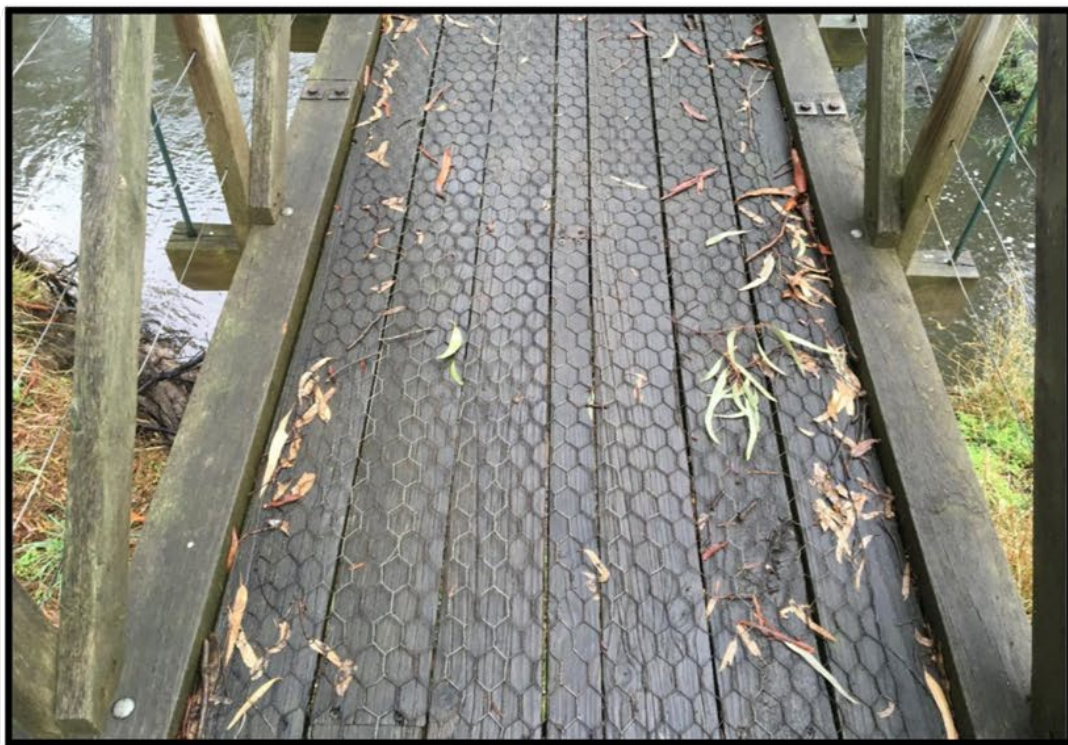
Non-compliant "chicken wire" installed on deck planks

- Non-compliant "chicken wire" affixed to timber deck requires removal as a matter of urgency as it presents a tripping hazard and does not provide a suitably non-slip walkway (supply and install mini mesh FRP decking or similar),

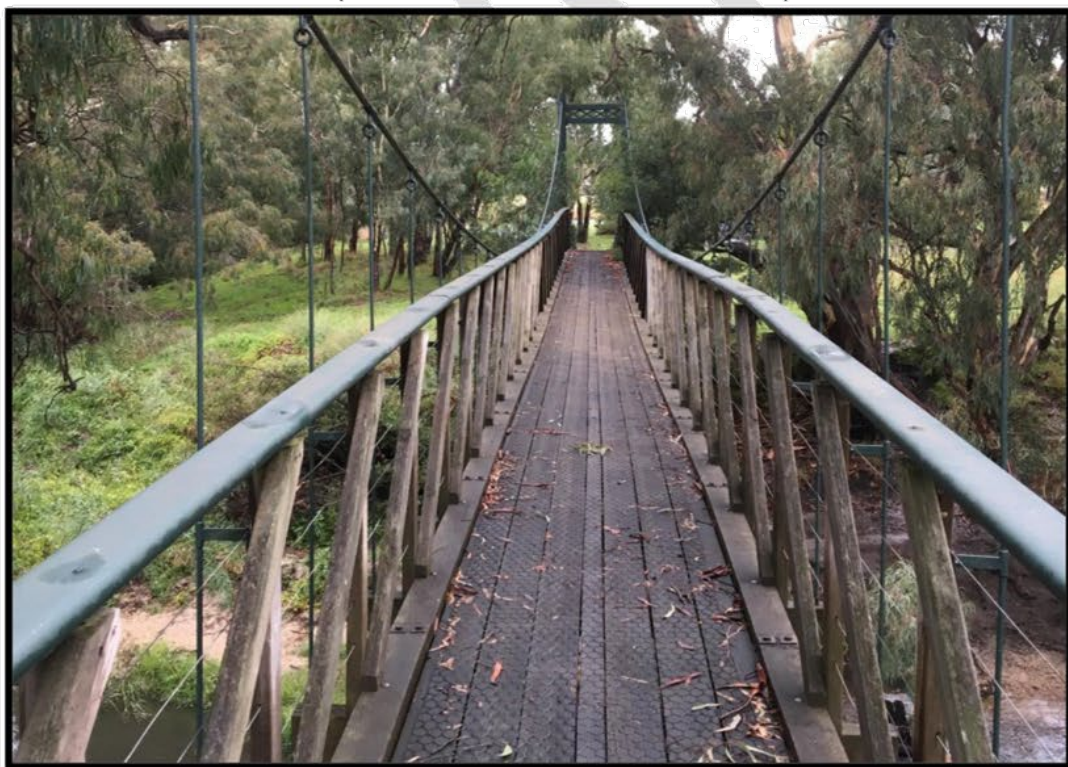
It is likely the damage identified is a result of floodwater and debris catching on the upstream catenary cable and stretching it causing elongation of the cable itself and the structure to noticeably sag on the upstream side.

Deck is noticeably twisting towards upstream

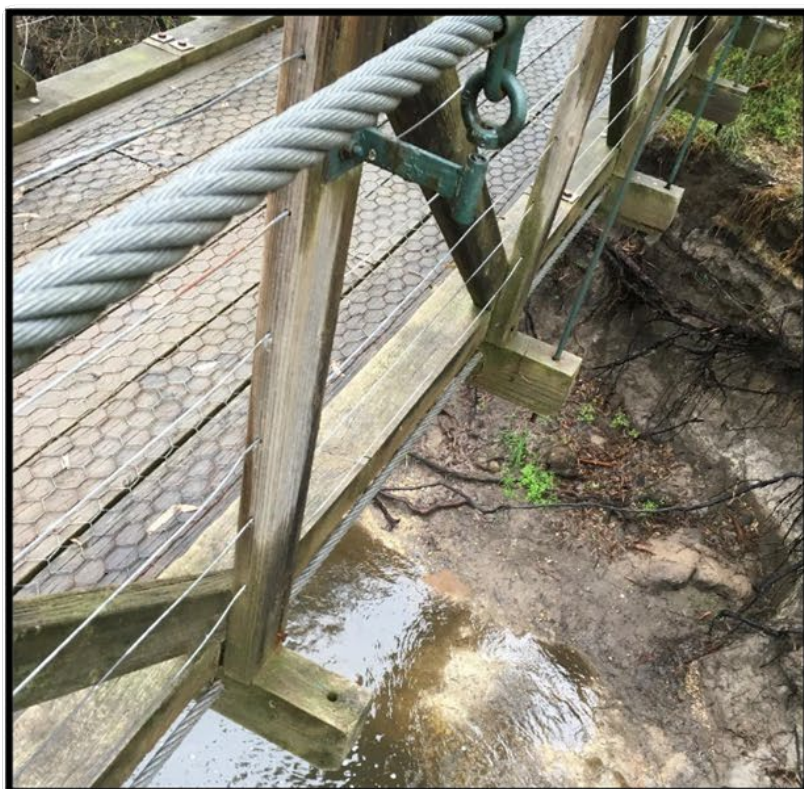
Missing suspender/ dropper

2.08	Suspenders	Bent and/ or missing bars	Straighten and/ or replace bars Add individual lengths	1	item	5,500.00	5,500.00	0%	100%	Bent bars are replaced also, each new bar is made onsite

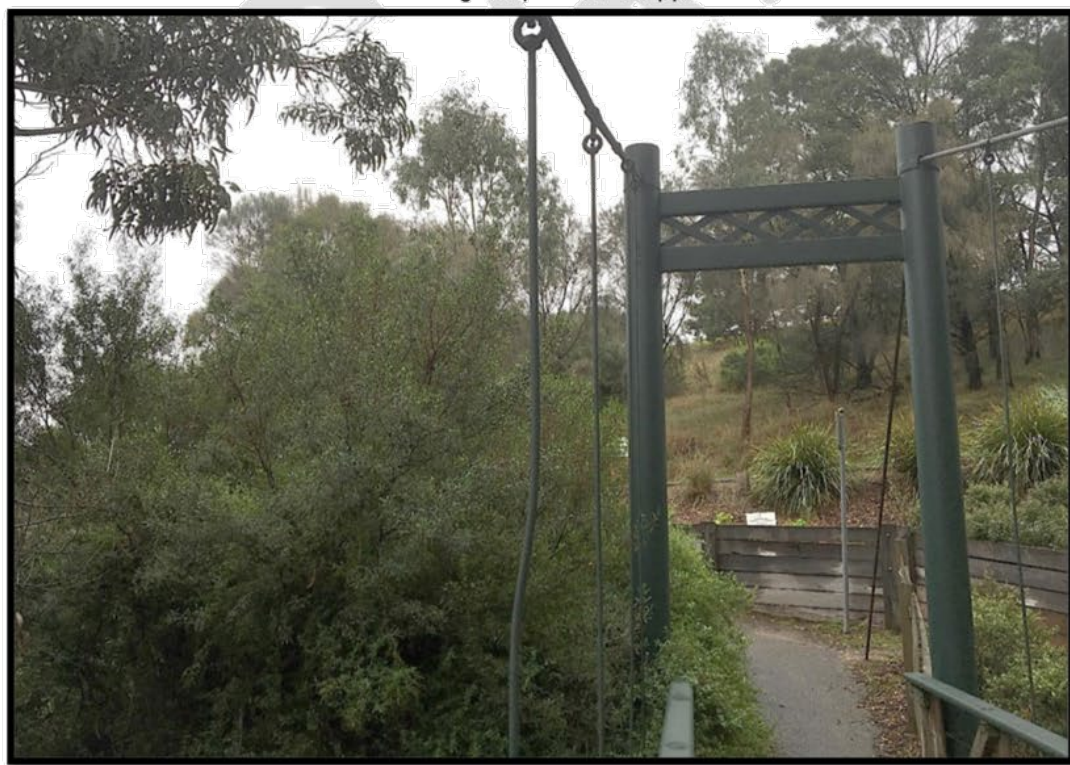
Example of bent droppers/ suspenders

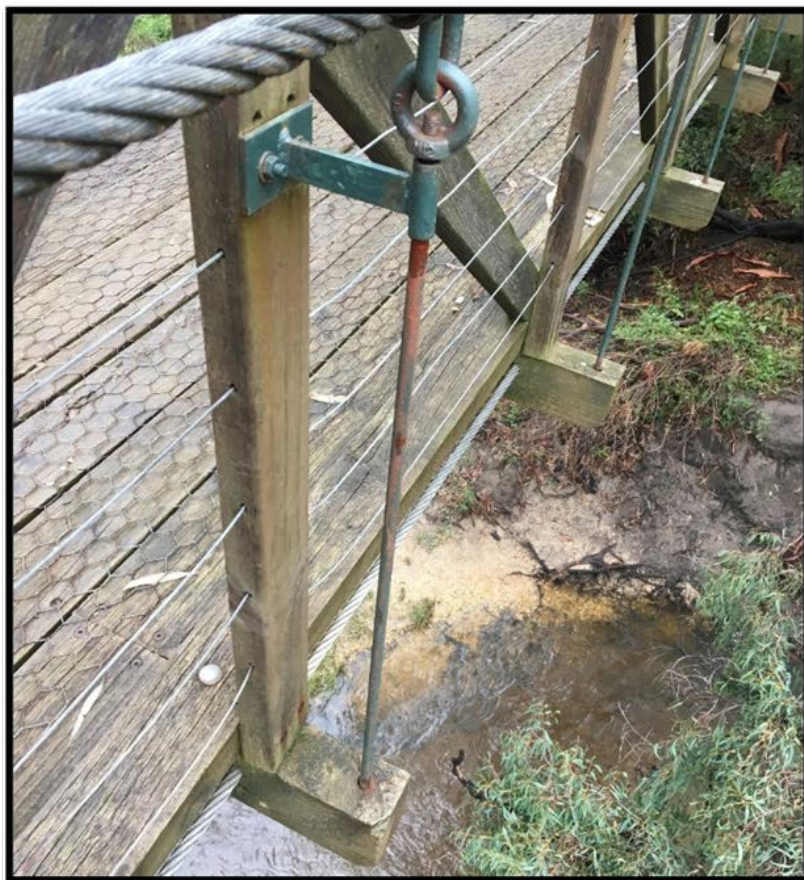
Example of corrosion to droppers

2.09		Corroded and painted over, impeding adjustment	Adjust as necessary	1	item	10,500.00	10,500.00	50%	50%	Includes cleaning and repainting
2.10	Fixings	Missing and/ or loosened screws	Tighten and/ or replace screws over entire structure as required	1	item	280.00	280.00	100%	0%

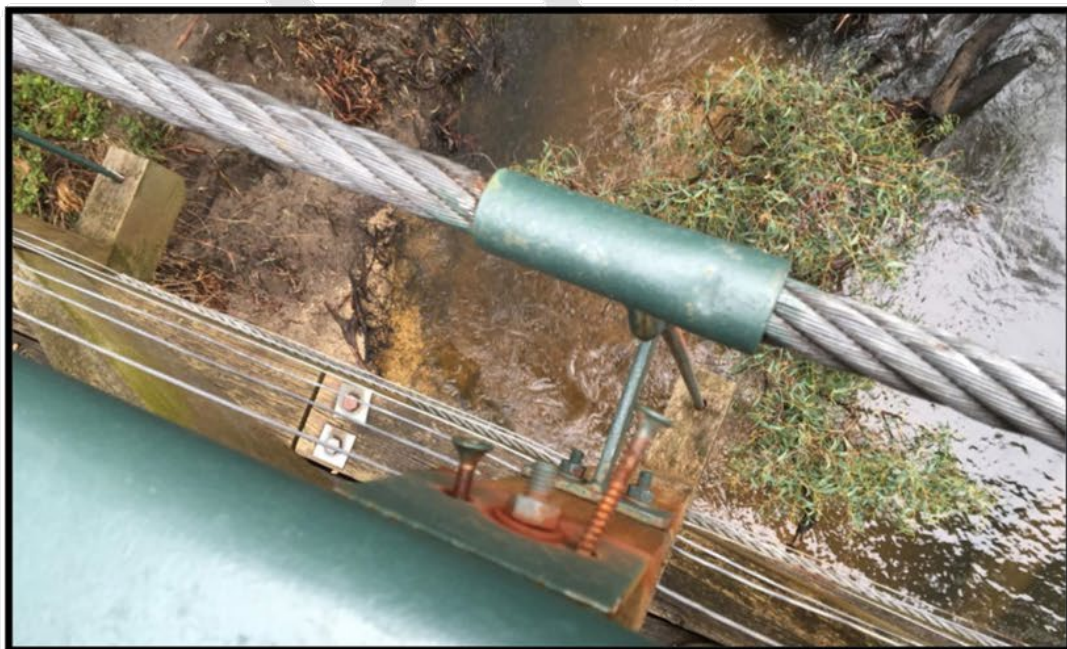
Example of corrosion and loosened fixings

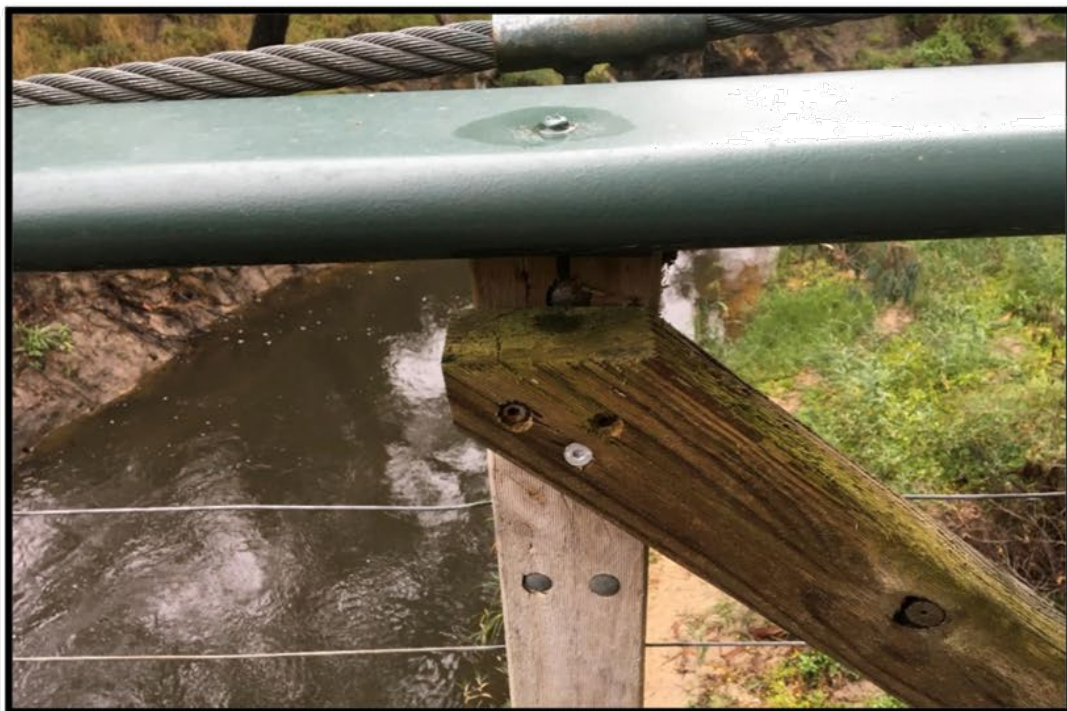
Guardrail deterioration and replaced fixings

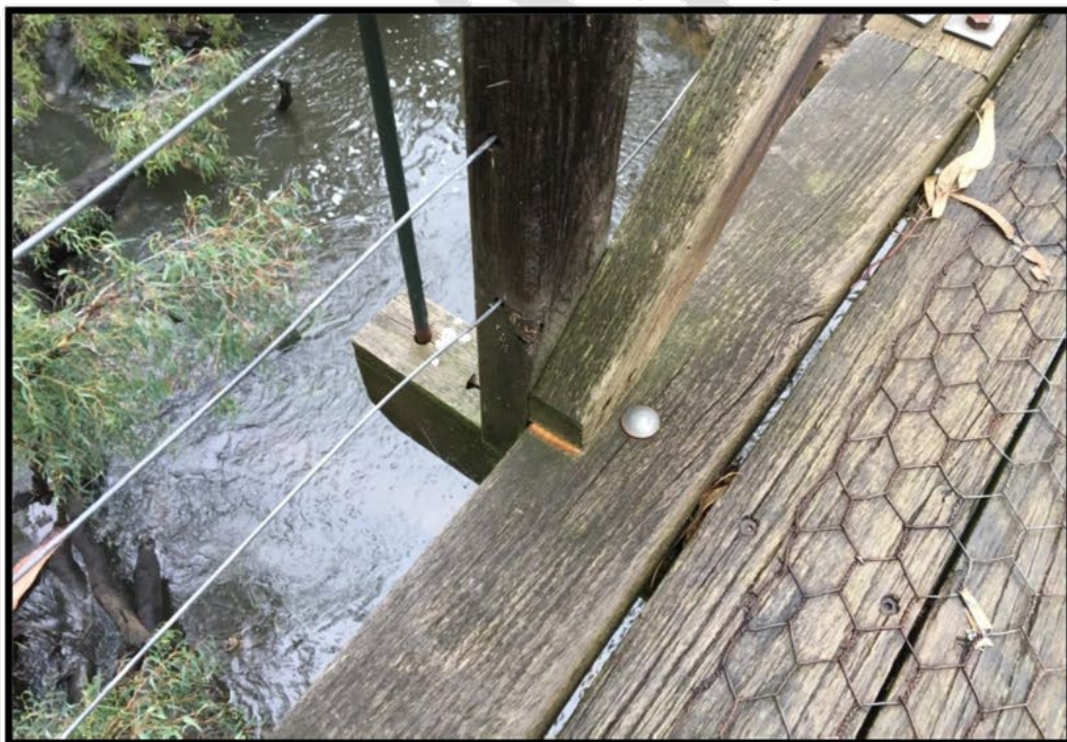
Signs of movement at deck/ railing joint

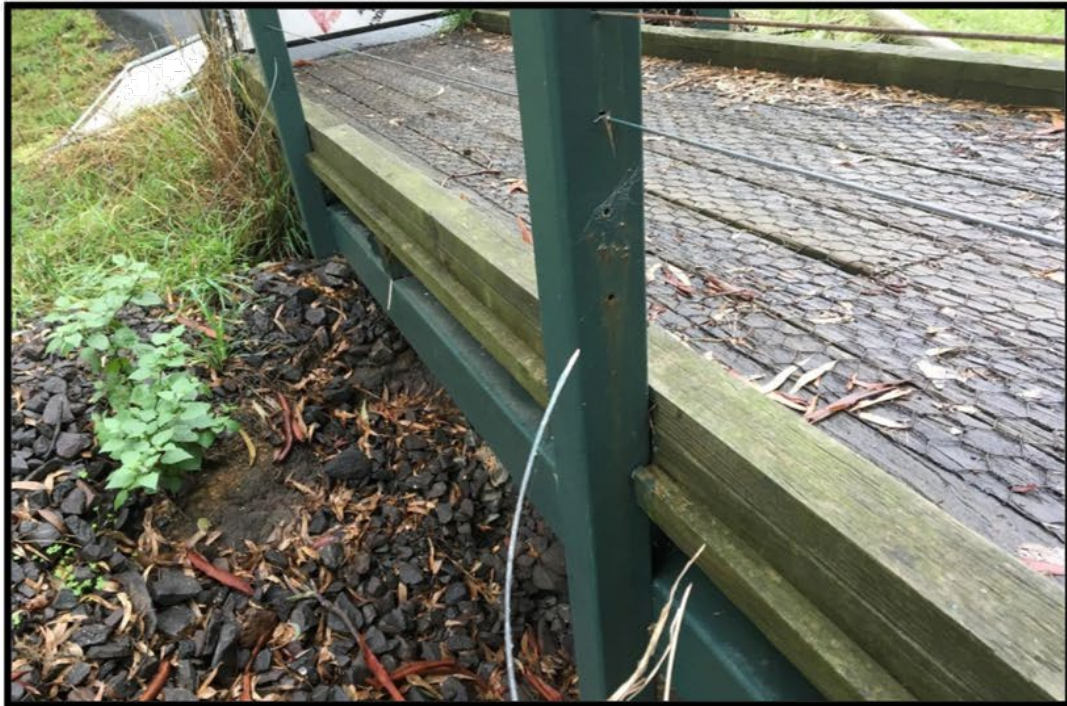
Broken strands of non-compliant horizontal wire fence

- Previous repairs/ maintenance efforts to the threaded adjustment heads of the suspenders/ droppers may have hindered future adjustment efforts,
- Non-compliant horizontal guardrail is a climbing hazard which requires replacement as a matter of urgency (supply and install ARC roll top mesh or similar),

2.12	Barrier / Guardrail	Broken and/ or damaged horizontal wire	Repair horizontal wire	1	item	2,040.00	2,040.00	50%	50%	
<b>3.00 Approaches and Signage</b>

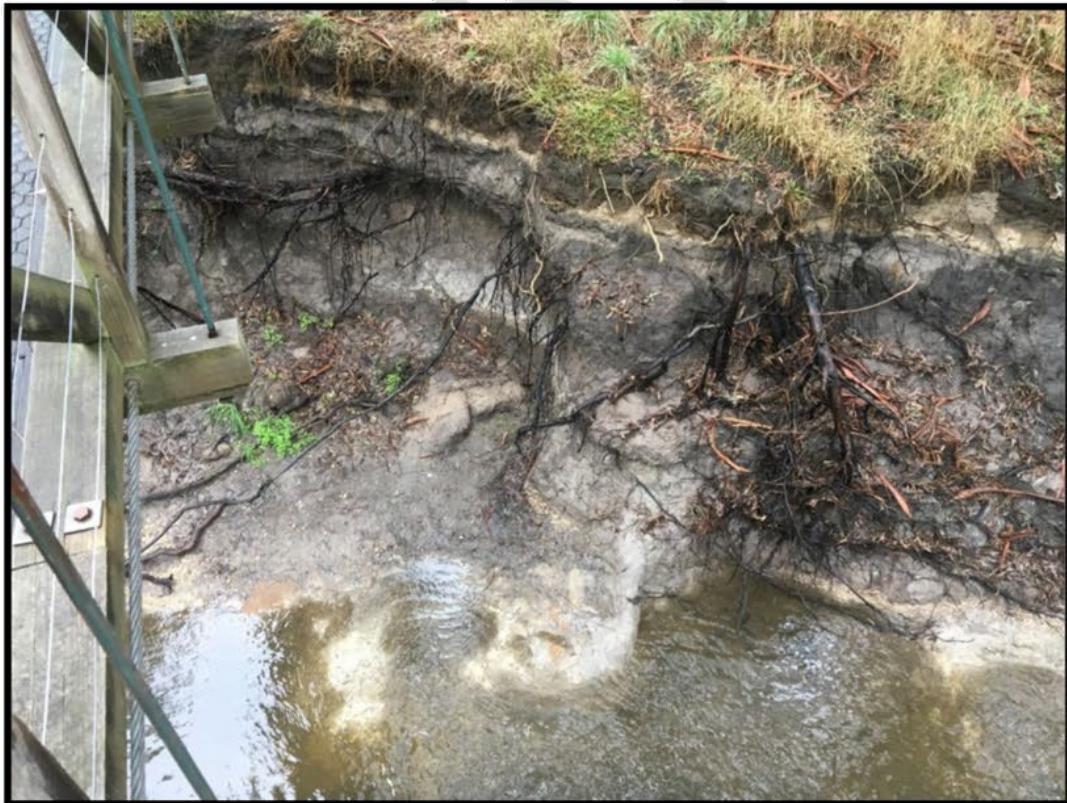
Significant scour to waterway does not affect bridge structure at this stage. To be referred to catchment authority for repairs
