Joint Validation Modelling Report

Teesdale Flood Risk Identification Study

Golden Plains Shire

12 April 2023

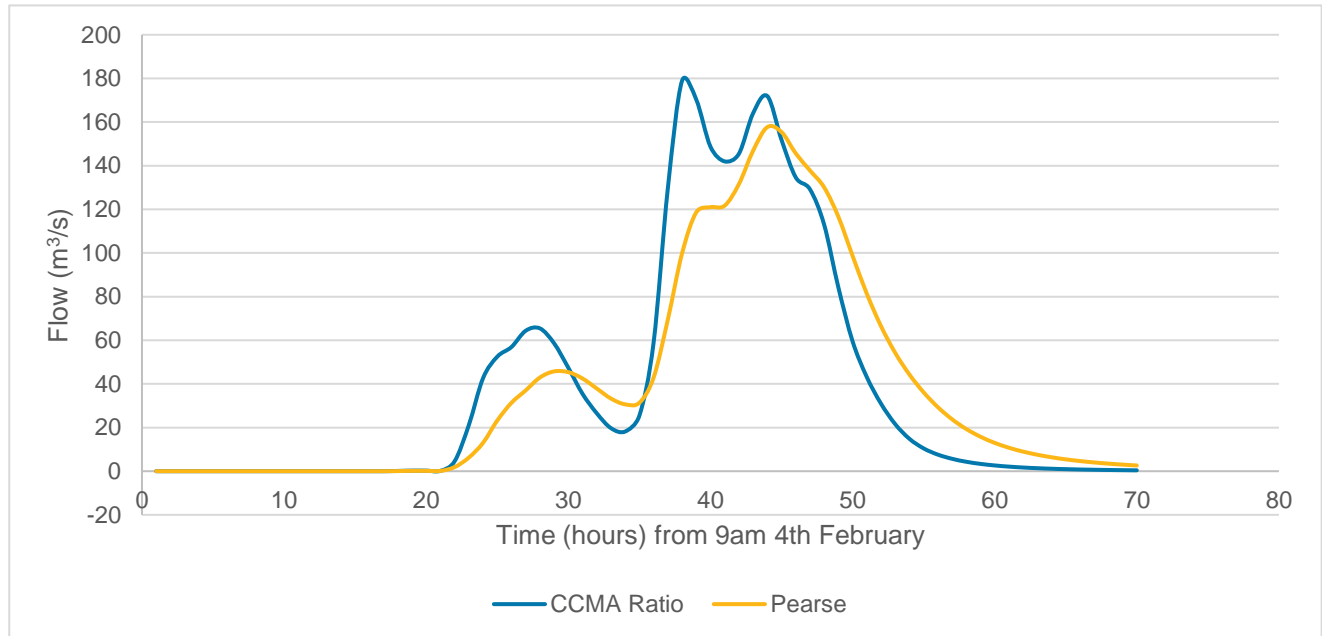
Figure 5-2 February 1973 modelled streamflow at Teesdale Bridge

Flow hydrographs extracted from the RORB model at the Bannockburn-Shelford Road bridge are shown in Figure 5-2 for the two modelled K_c values discussed in [section 2.1.5](#). The peak flow rates between the two events are similar for both k_c values with the CCMA value (18.9) producing a peak flow rate of 180 m³/s compared to 158 m³/s. Adopting Pearse k_c of 32.9 shows a relatively large delay in the peak timing (~8-10 hours).

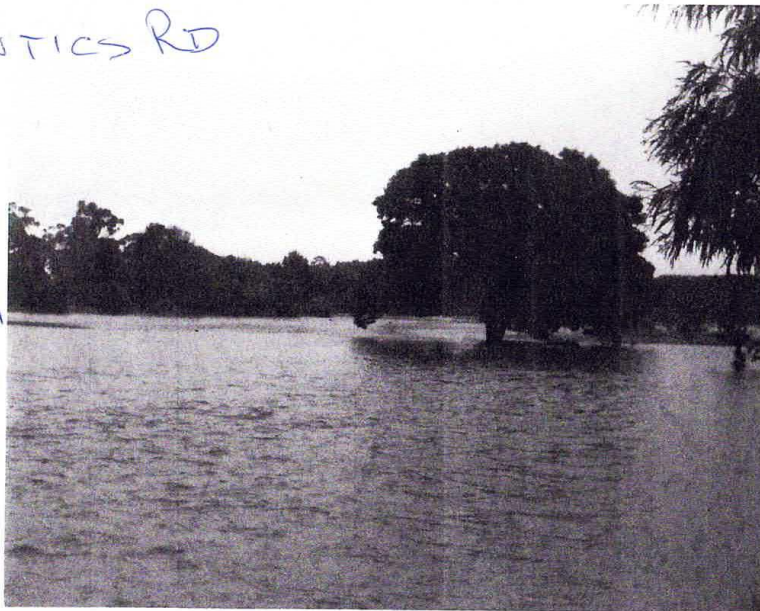
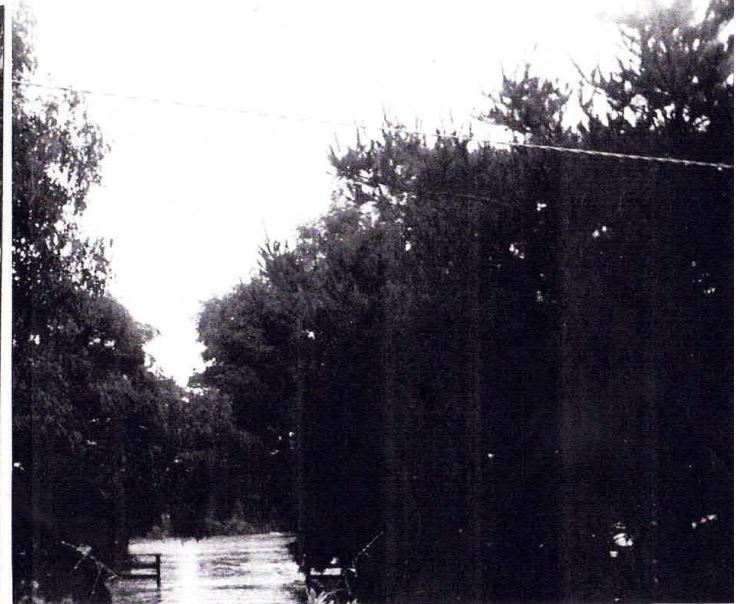
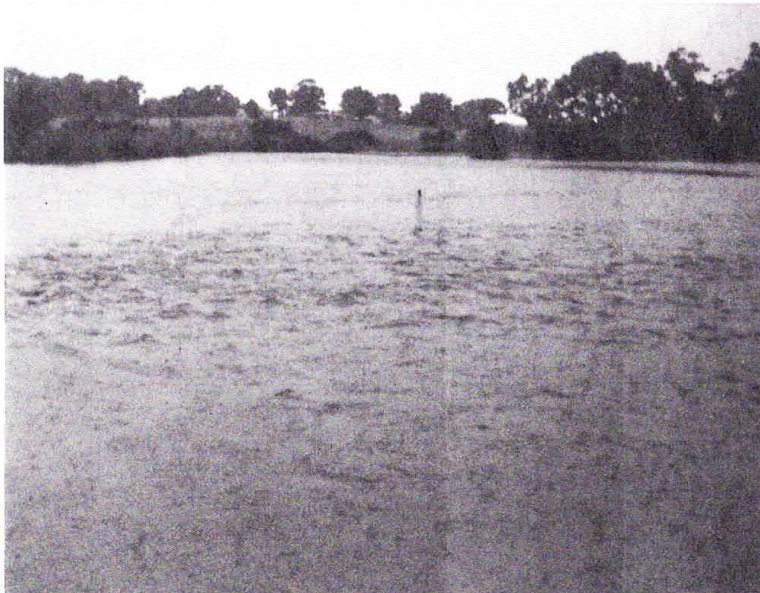
Figure 5-5 Photographs of 1973 flood event provided by the resident of 59 Pantics Road

The similarities between the two scenarios provide little point of separation at a broader scale. It is recommended the maps be presented for comment by the community to identify if any of the subtle differences can be reconciled with anecdotal evidence. One point of difference between the two model runs occurs at the Bannockburn-Shelford Road bridge, where the CCMA ratio run completely overtops the road while the Pearse ratio leaves small islands at the bridge abutments. The peak flood depths for the study area and township are shown in Figure 5-3 to Figure 5-4 and photos along Pantics Road from the event are shown in Figure 5-5.

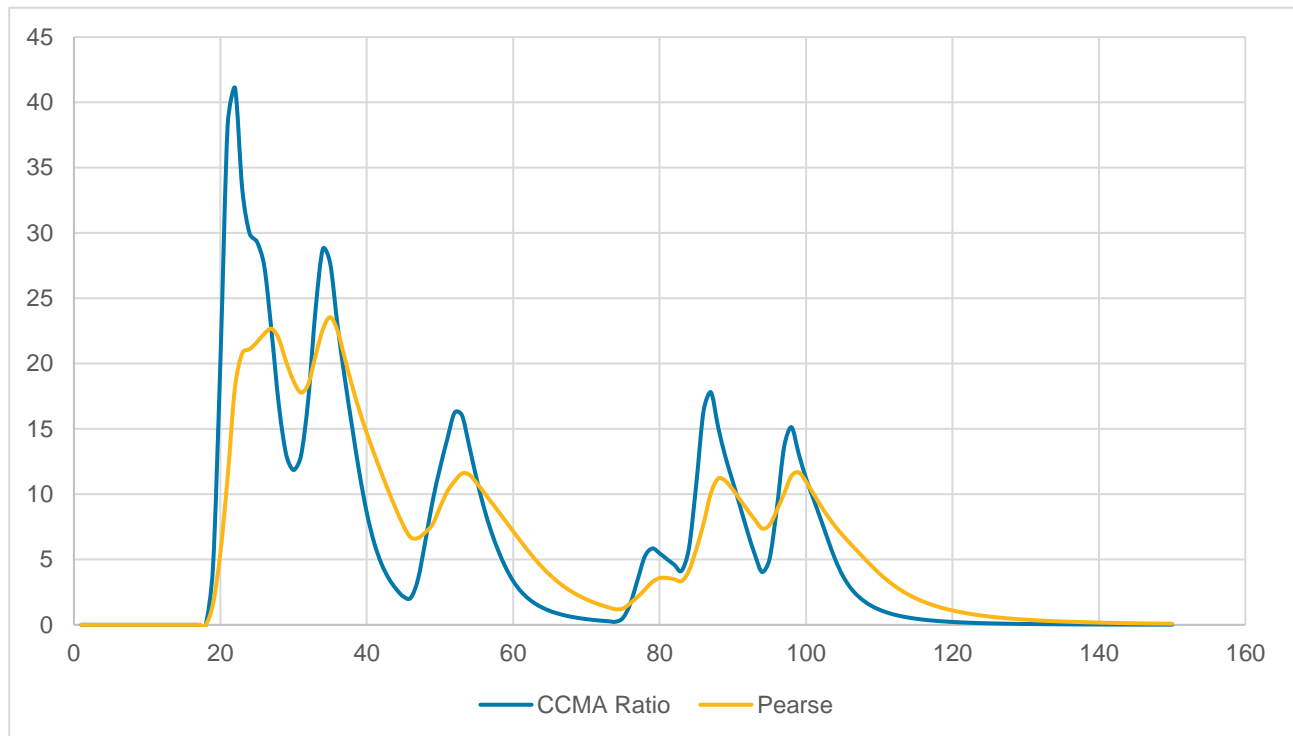
Figure 5-11 January 2011 modelled streamflow at Teesdale Bridge

Flow hydrographs extracted from the RORB model at the Bannockburn-Shelford Road bridge are shown in Figure 5-11 for the two modelled K_c values discussed in [section 2.1.5](#). Much like the April 2001 event, the January 2011 event is characterised by bursts of rainfall which show the attachment response is highly sensitive and the K_c parameter produces significant changes in the peak flows observed with 41 m³/s (CCMA) and 24 m³/s (Pearse). Lower values of K_c produce a hydrograph with significantly varying peaks and troughs, while higher values of K_c produce a more smoothed hydrograph.

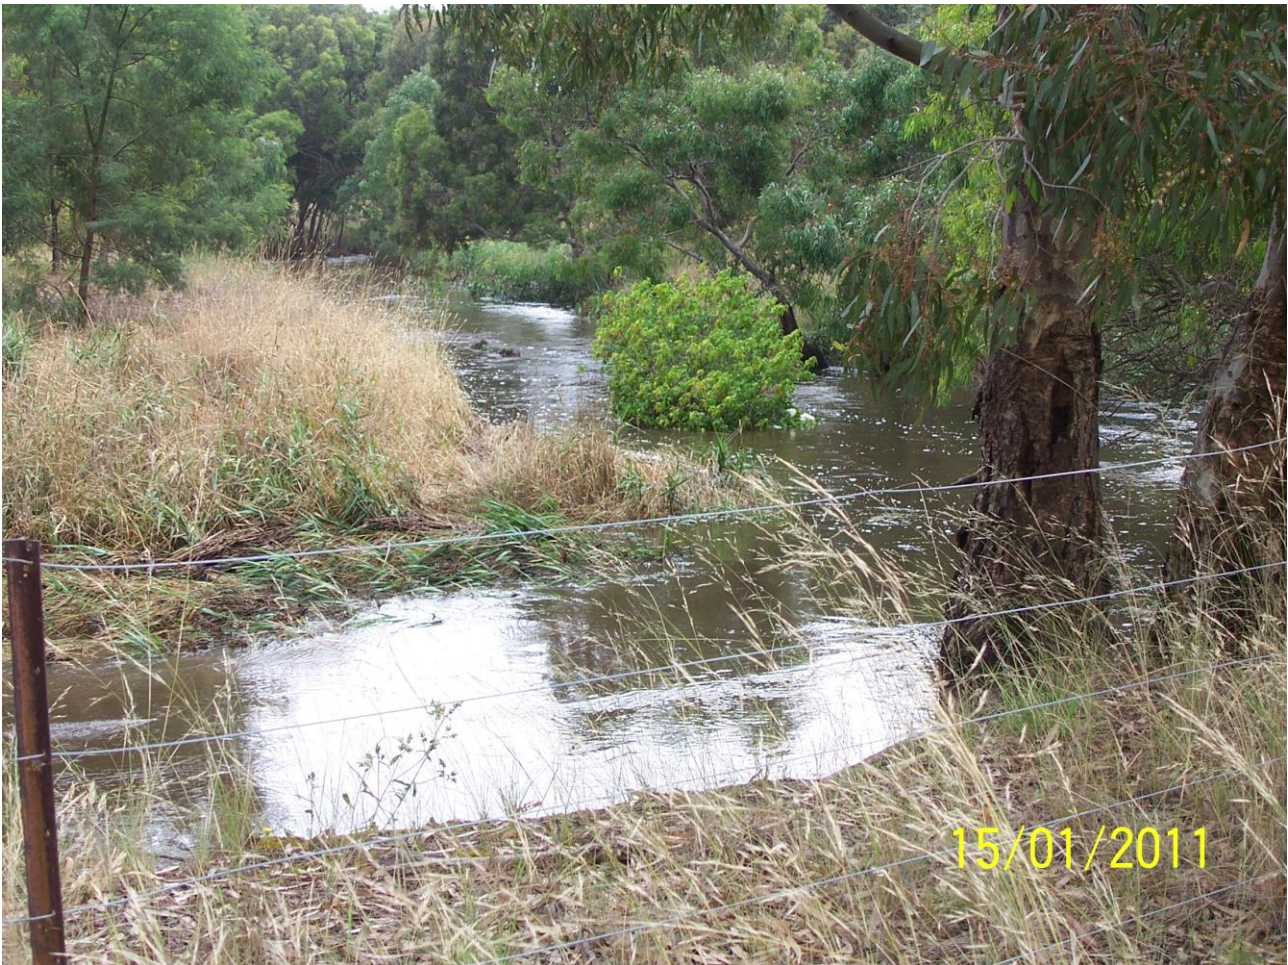
Photographs for this event have been provided by residents located in Sutherland Street at the community consultation session. The photos show water in the Creek being high but not out of bank at that location. The Pearse K_c equation replicates this while the CCMA equation does not, with the latter showing a breakout of flows onto 75 Sutherland Street which is understood to not have occurred.

Figure 5-14 Photo provided by the residents of 75 Sutherland Street Teesdale during the 2011 flood showing flows contained within Native Hut Creek

For the 2011 event, the lack of flooding on 75 Sutherland Street observed with the higher k_c value using the Pearse equation gives some confidence in the adoption of the higher K_c value. As discussed earlier, the flows for this event are understood to have generally stayed within bank. Discussions held at the second community consultation session held in March 2023, further confirmed that no breakouts were observed by the community during the January 2011 event.
