Summary Report

Teesdale Flood Risk Identification Study

Golden Plains Shire

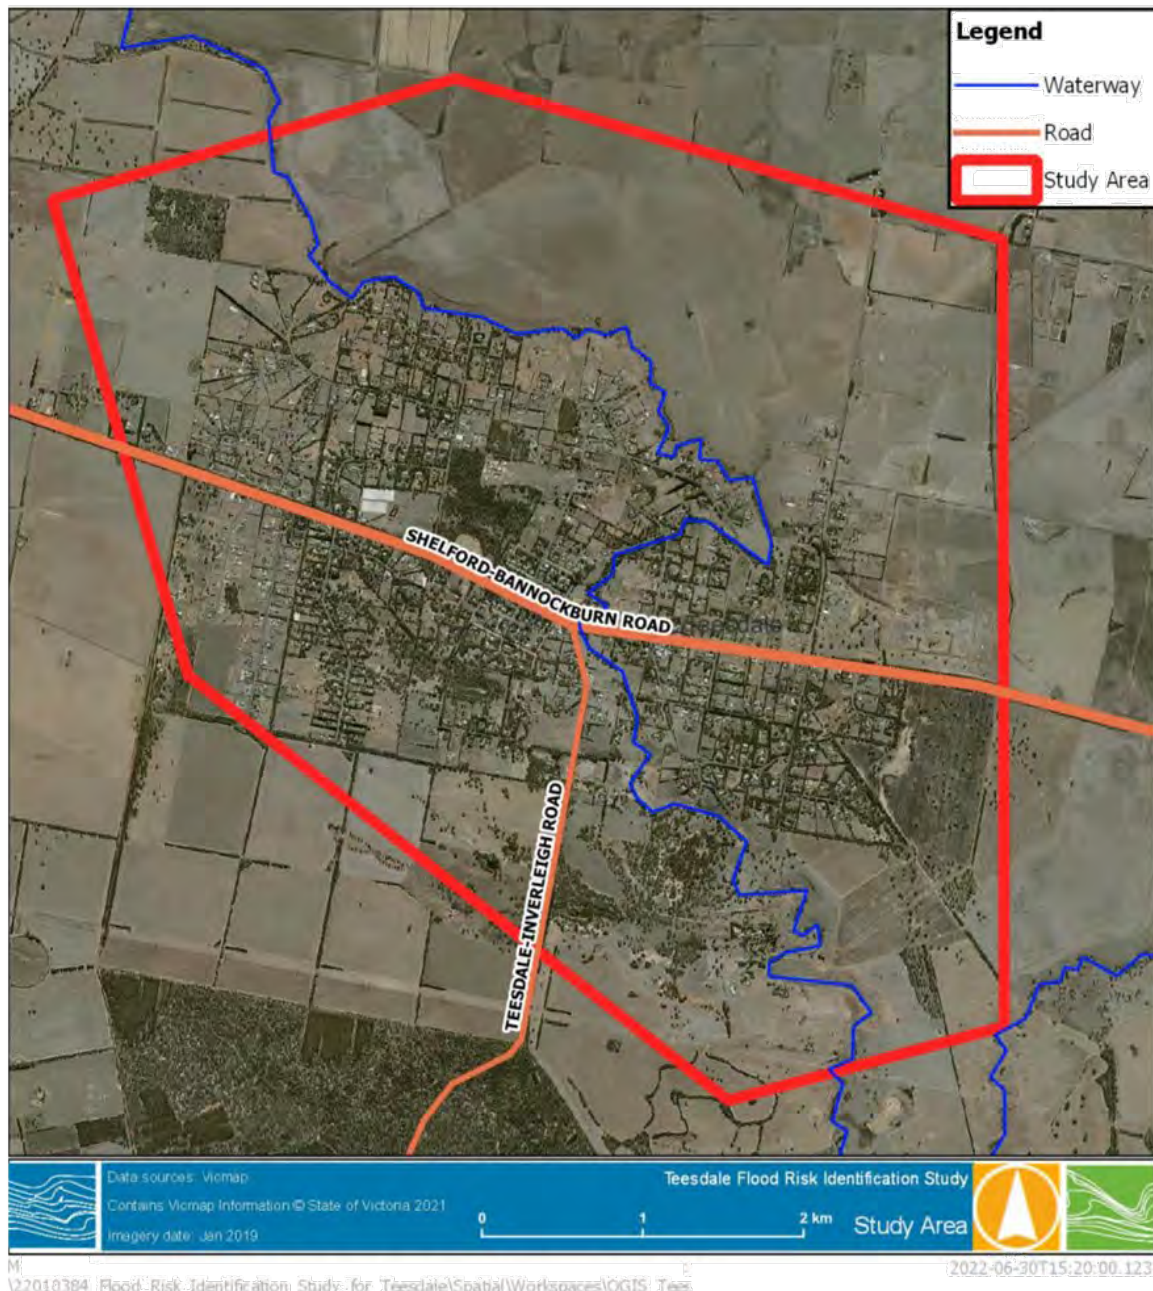
Figure 1-1 Teesdale Flood Risk Identification Study - Study Area

Water Technology has been commissioned by Golden Plains Shire Council (Council) to undertake the Teesdale Flood Risk Identification Study. The investigation area covers the Native Hut Creek and tributaries in the township of Teesdale, as shown in Figure 1-1. Teesdale is identified as a Priority Flood Risk Area in the Corangamite Regional Floodplain Management Strategy (2018), which identifies both riverine and flash flood risks for the town and states that “*flooding associated with Native Hut Creek has damaged several residential properties*”.

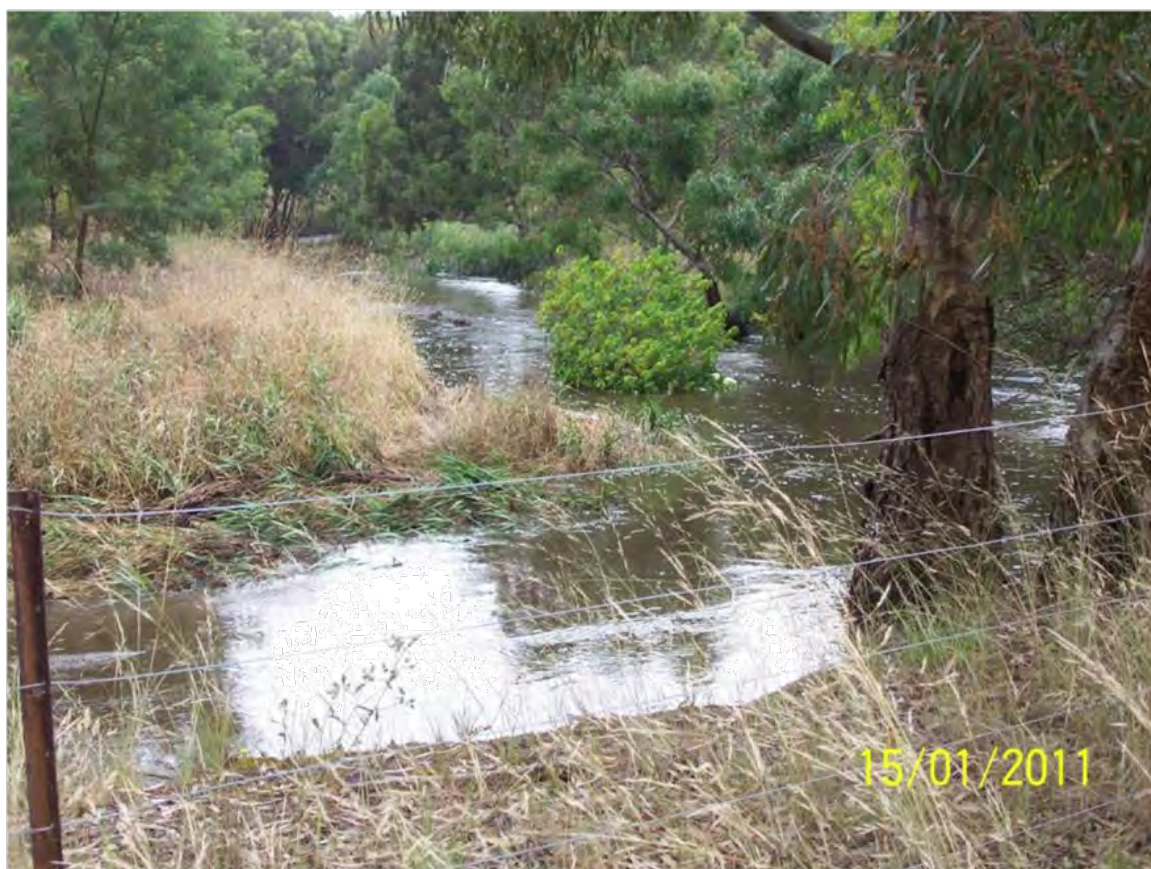
Figure 3-5 Photo provided by the residents of 75 Sutherland Street Teesdale during the 2011 flood showing flows contained within Native Hut Creek

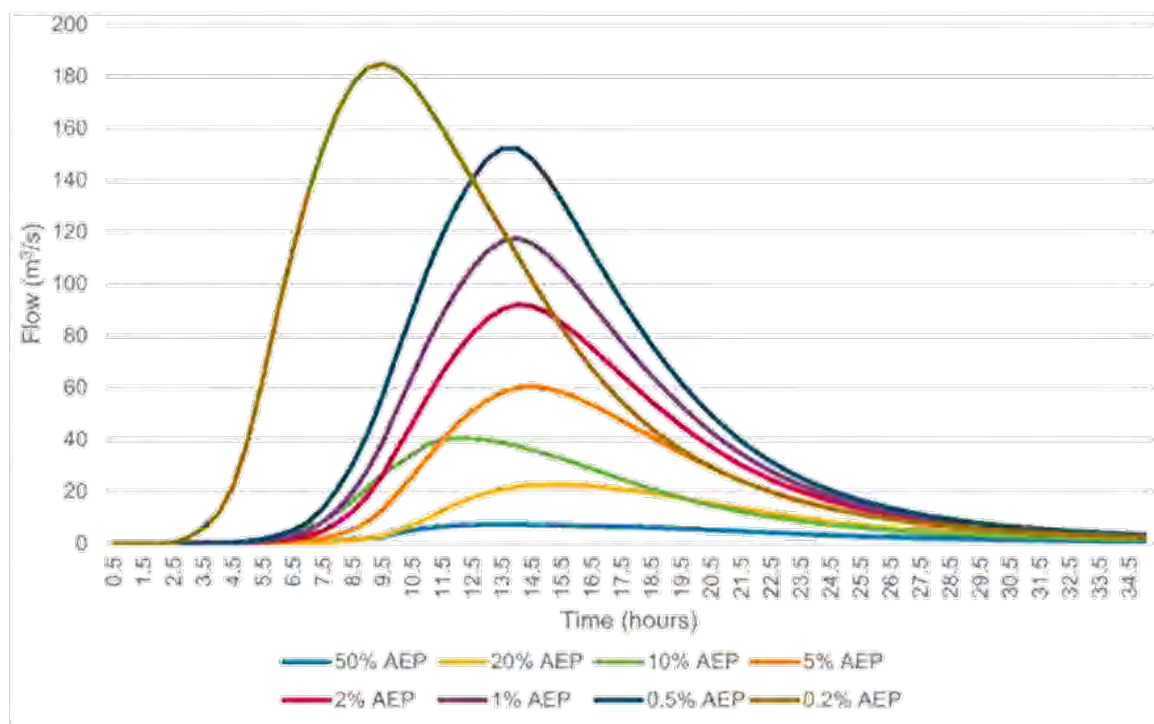
Figure 4-1 Design hydrographs, Native Hut Creek at Bannockburn-Shelford bridge

The RORB hydrologic model was ran for the 50%, 20%, 10%, 5%, 2%, 1%, 0.5%, 0.2% and PMF events. Critical event hydrographs at the Bannockburn-Shelford Road bridge for the design events (excluding the PMF) are shown in Figure 4-1 below.

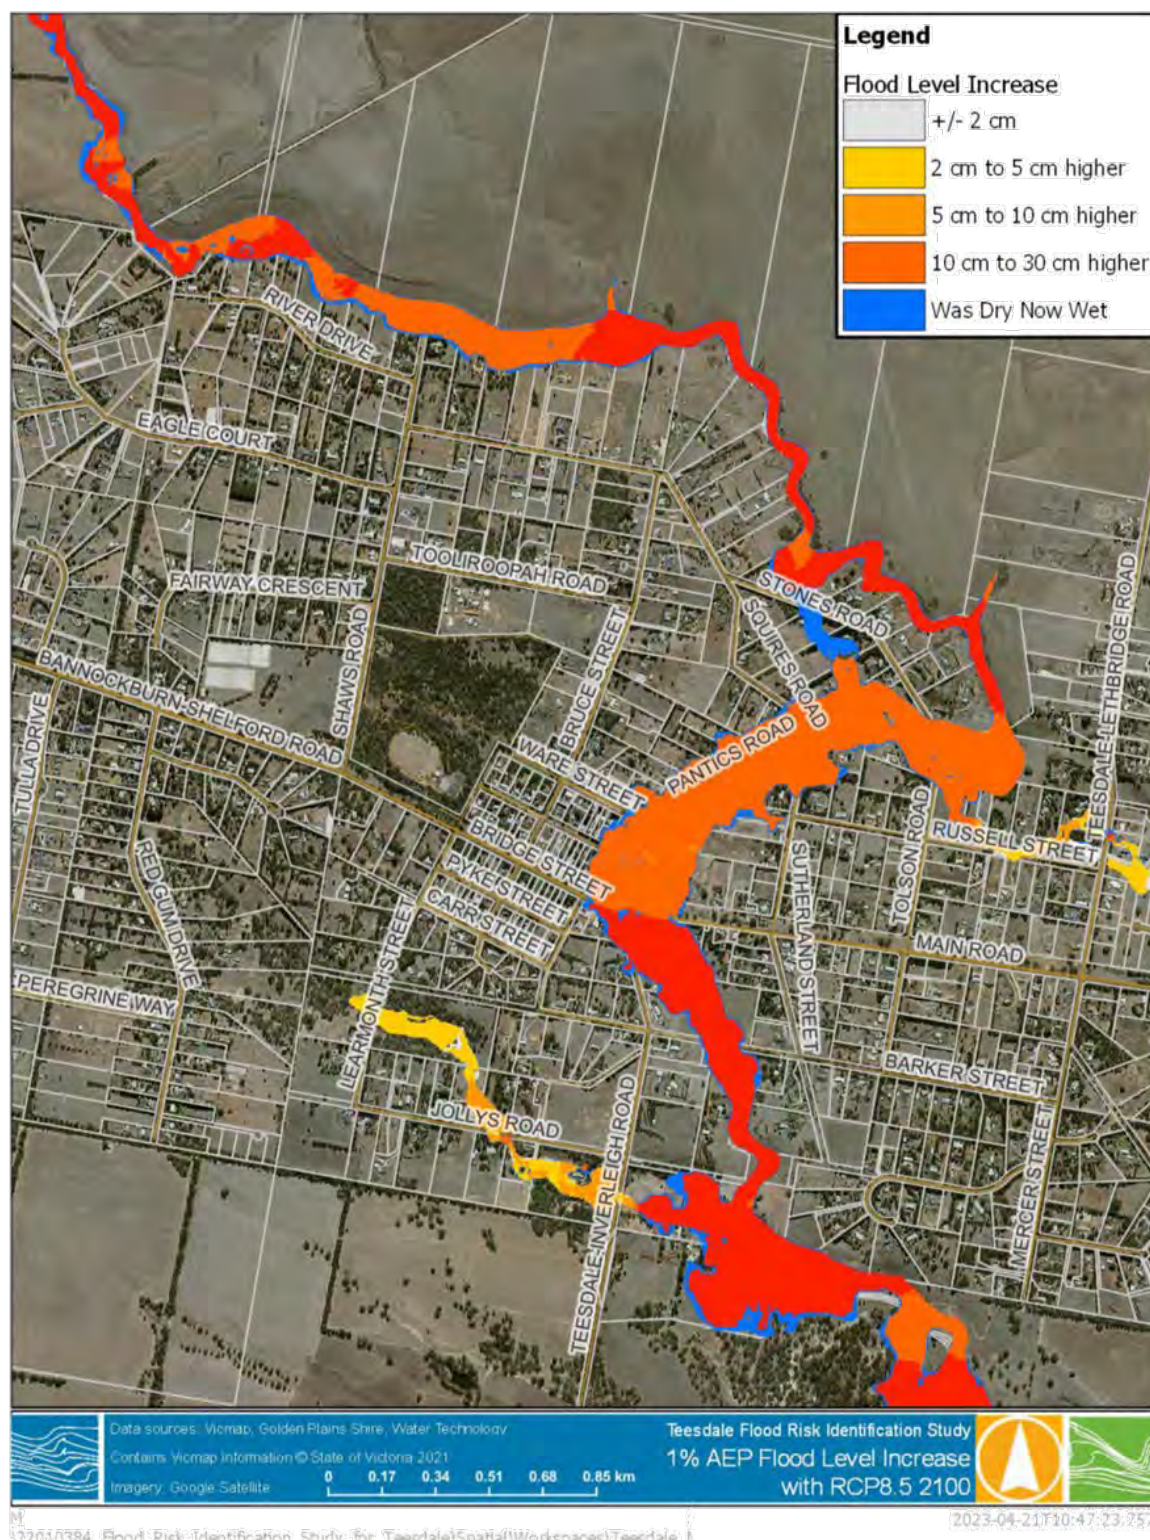
Figure 4-4 Flood level increase under RCP8.5 projections to 2100 for the 1% AEP event

Figure 4-4 shows the difference in flood levels between the existing conditions 1% AEP event and the 2100 1% AEP under RCP8.5. In the township, flood levels increase in the order of 0.15 to 0.25 metres upstream of the bridge where the floodplain is relatively wide. Downstream of the bridge, increases in flood levels are between 0.4 and 0.5 metres, where the floodplain is more confined.

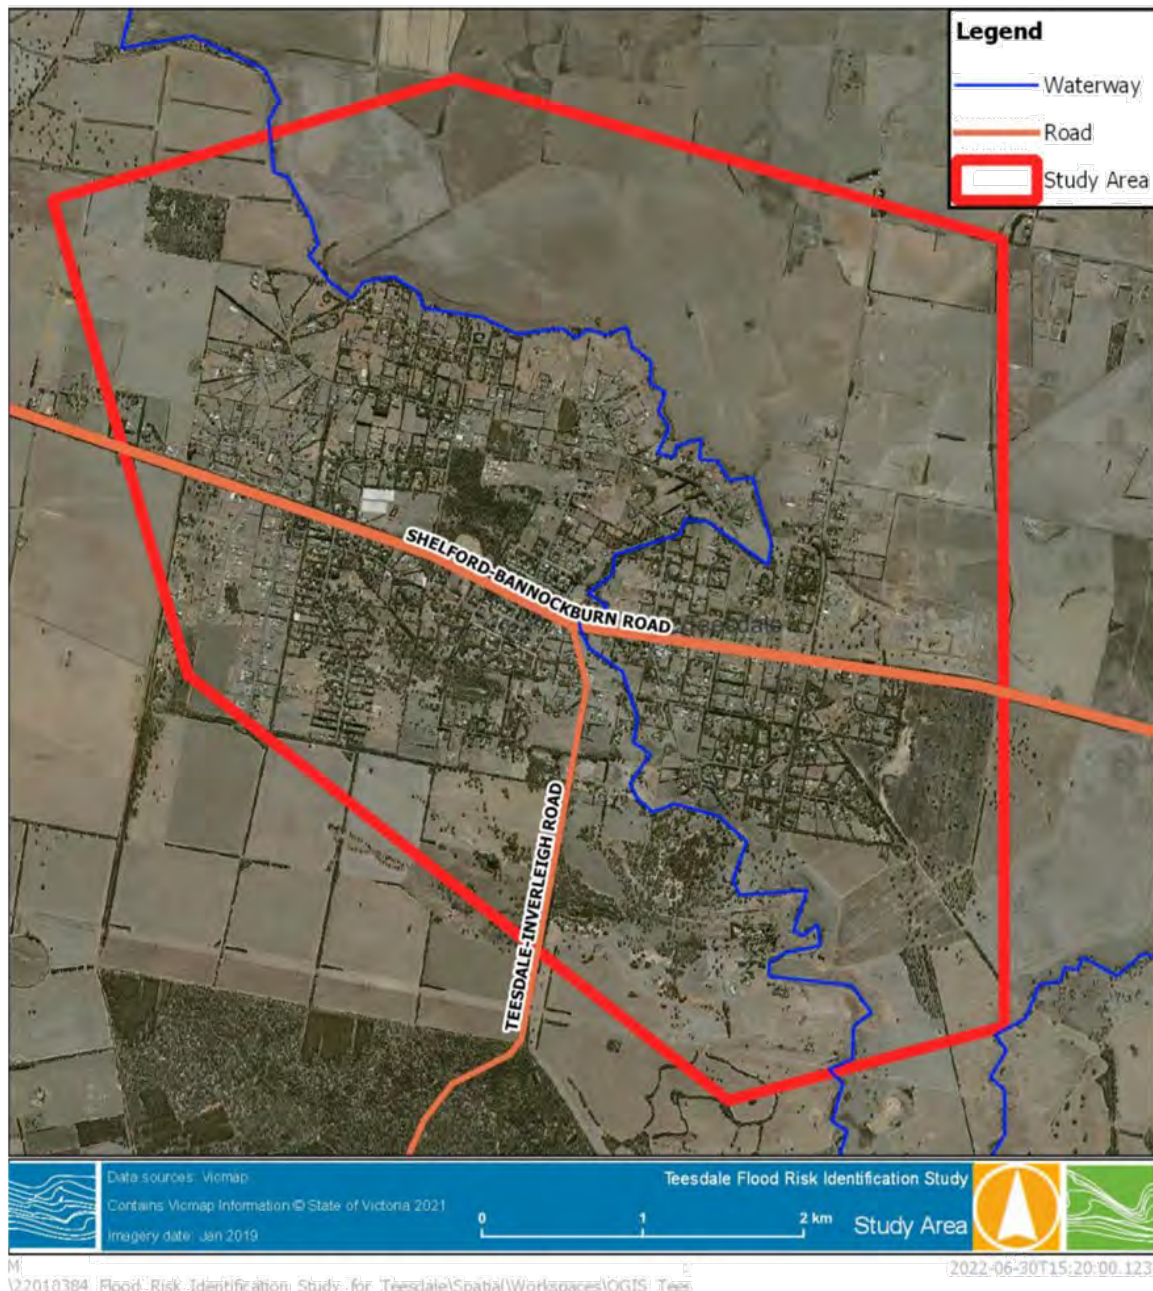
Figure 1-1 Teesdale Flood Risk Identification Study - Study Area

The catchment within and upstream of the study area is mostly cleared agricultural land and the main waterway (Native Hut Creek) has several onstream dams of varying size along its alignment. The Native Hut Creek catchment draining to Teesdale is approximately 110 km². The entire catchment is located within the Golden Plains municipal area. The study area is focussed on the township of Teesdale and includes the following waterway structures:

- Two large on-stream dams approximately 3km upstream of the township.
 - An indicative assessment of the impact of the upstream dams was completed in R01 – Data Collation and Validation.
- Road crossings, formal or informal, at the following roads:
 - Tolson Road/Stones Road
 - Sutherland Street
 - Bannockburn-Shelford Road
 - Barkers Road
- Several off-stream dams throughout the town.

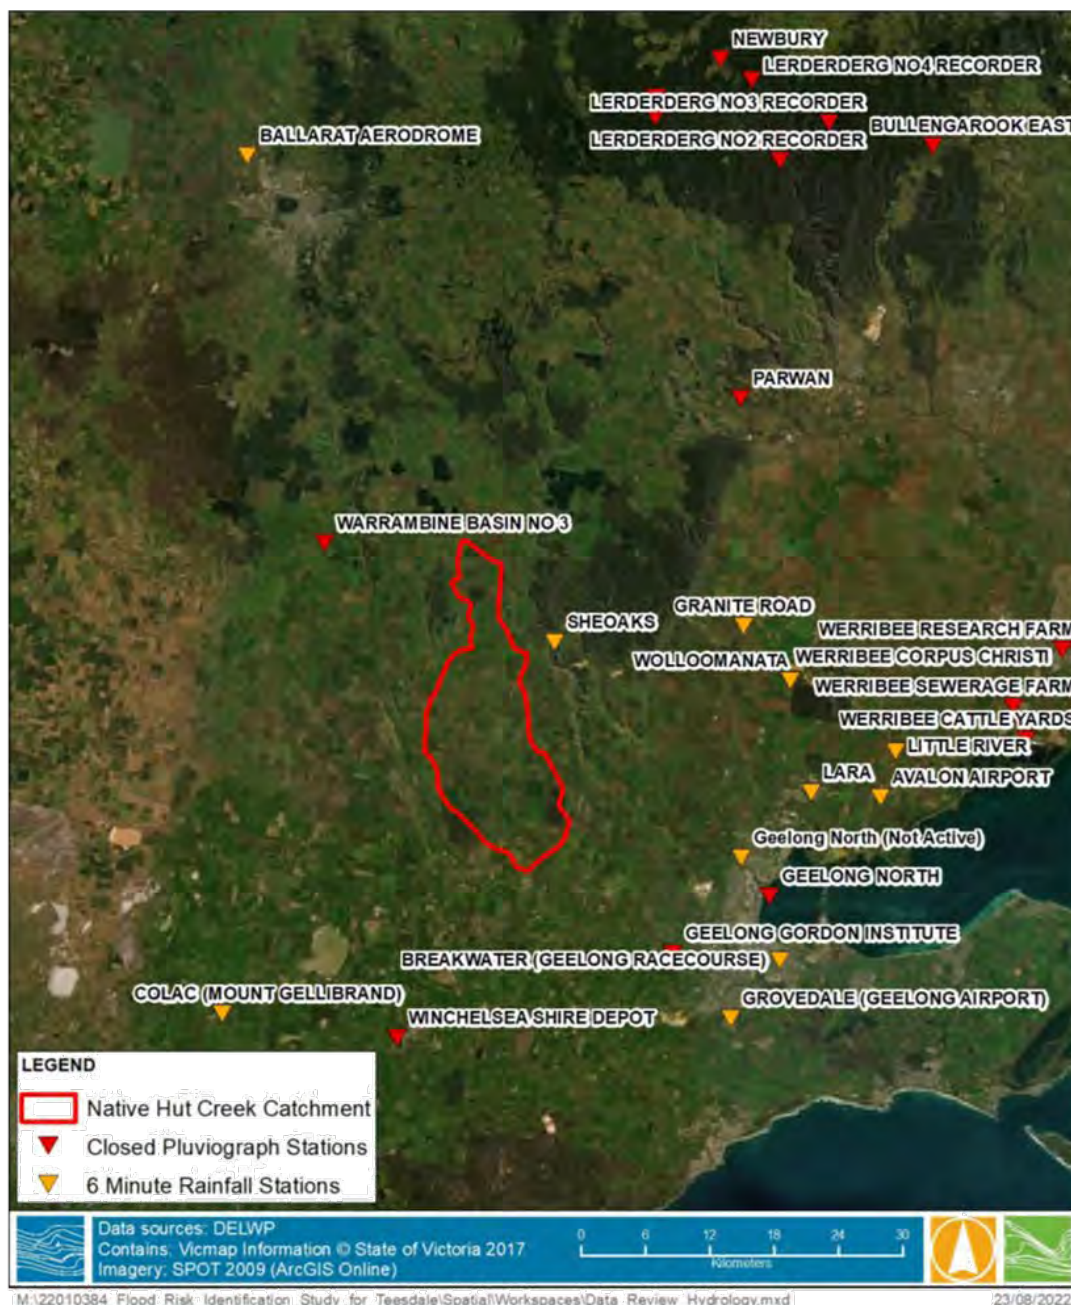
Figure 2-4 Pluviograph stations near Native Hut Creek Catchment

There are no sub-daily rainfall stations within the Native Hut Creek catchment. The locations of nearby current and closed sub-daily rainfall stations are shown in Figure 2-4. The nearest sub-daily catchment is Sheoaks, approximately 14.5 km northeast of Teesdale. Multiple sub-daily stations are available to the east of the catchment in more populated areas near Geelong and Lara, while to the west of the catchment stations are available at Colac and Ballarat.

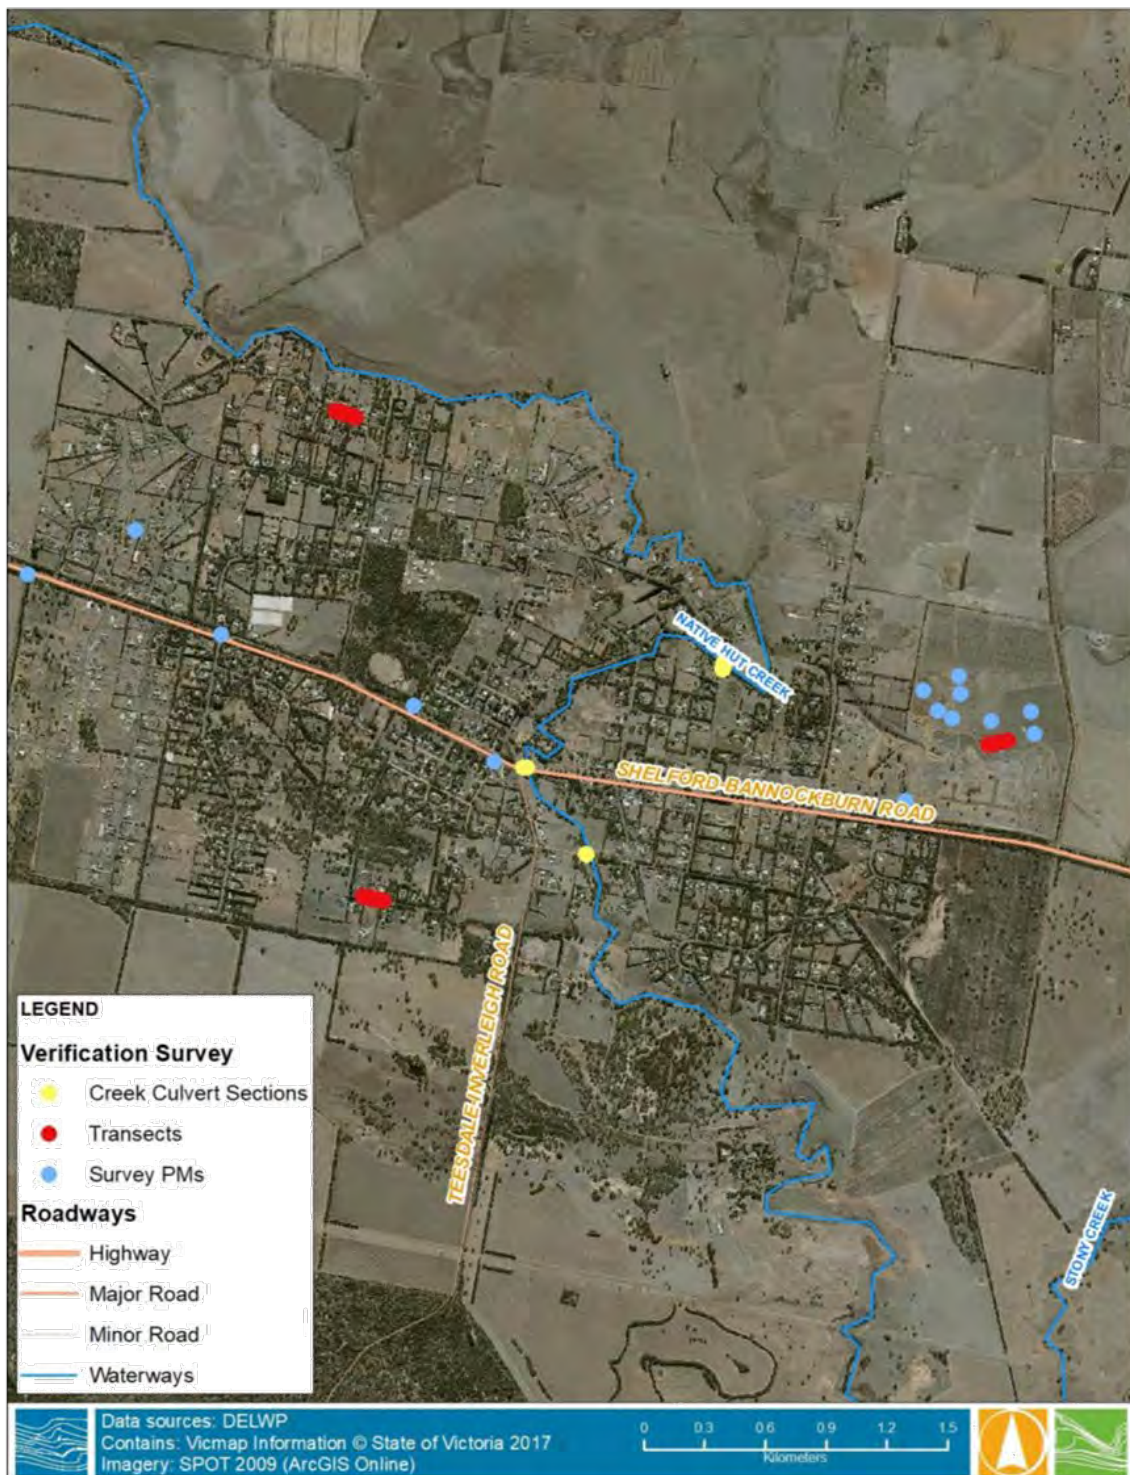
Figure 2-6 Verification Survey

The capture of ground survey at three locations within the study area was commissioned to assist with verification of the available LiDAR datasets (Figure 2-6). The survey consisted of transects along the crest of roadways shown in Figure 2-6. Each transect is approximately 100 m in length with a spot height every 5 metres. The transect results compared with available LiDAR datasets are presented in Table 2-7.

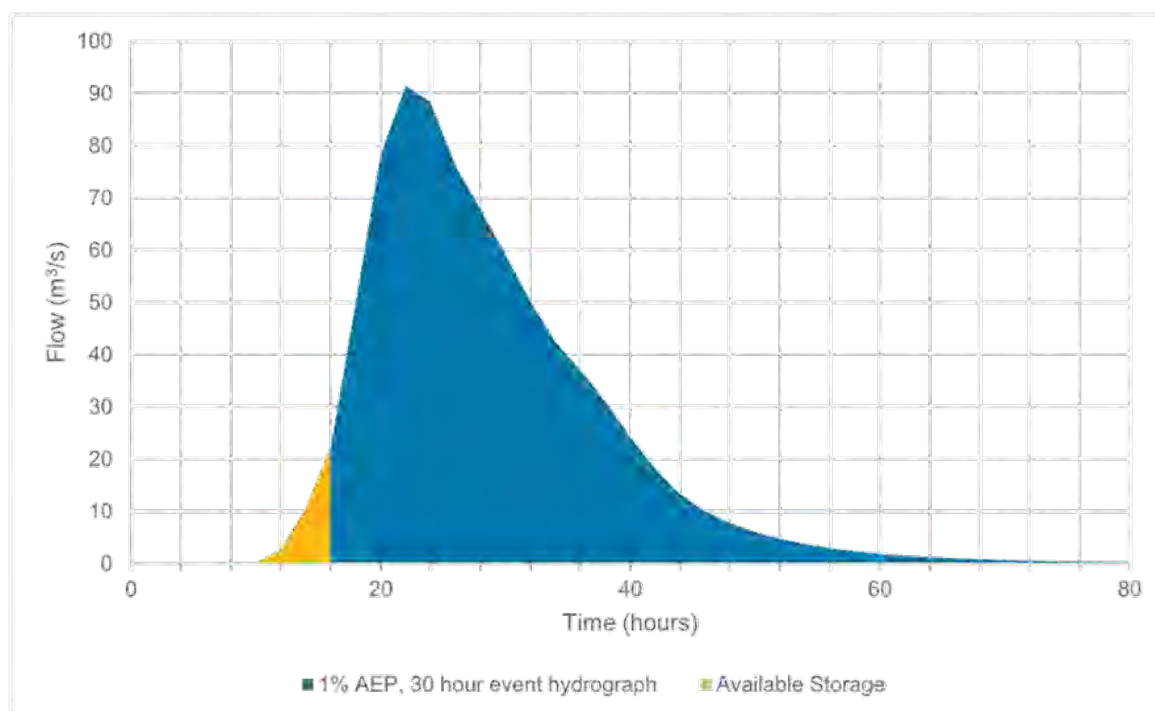
Figure 4-1: Example storage vs hydrograph volume comparison

In minor events the storage may have an impact on flood behaviour for Teesdale. Design modelling will adopt the conservative approach of assuming the storages are full however this should be considered as part of the broader antecedent conditions.

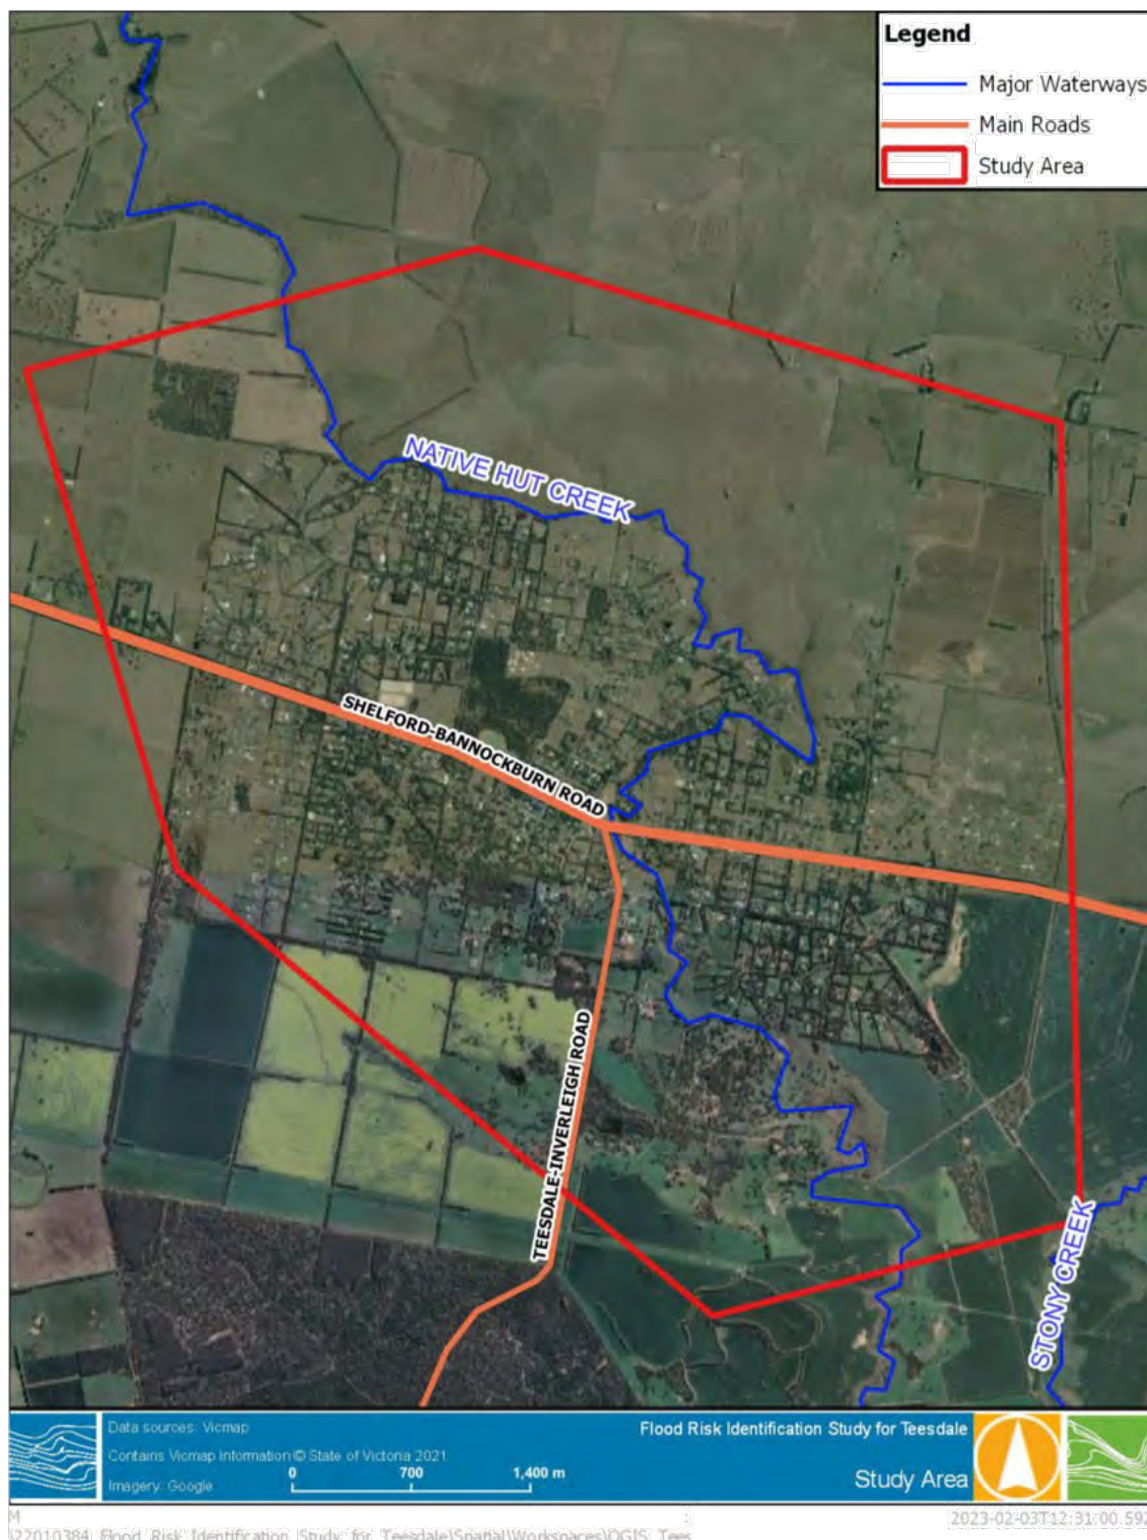
Figure 1-1 Study Area

Water Technology has been commissioned by Golden Plains Shire Council (Council) to undertake the Teesdale Flood Risk Identification Study. The investigation area covers the Native Hut Creek and tributaries in the township of Teesdale, as shown in Figure 1-1. Teesdale is identified as a Priority Flood Risk Area in the Corangamite Regional Floodplain Management Strategy (2018), which identifies both riverine and flash flood risks for the town and states that “*flooding associated with Native Hut Creek has damaged several residential properties*”.

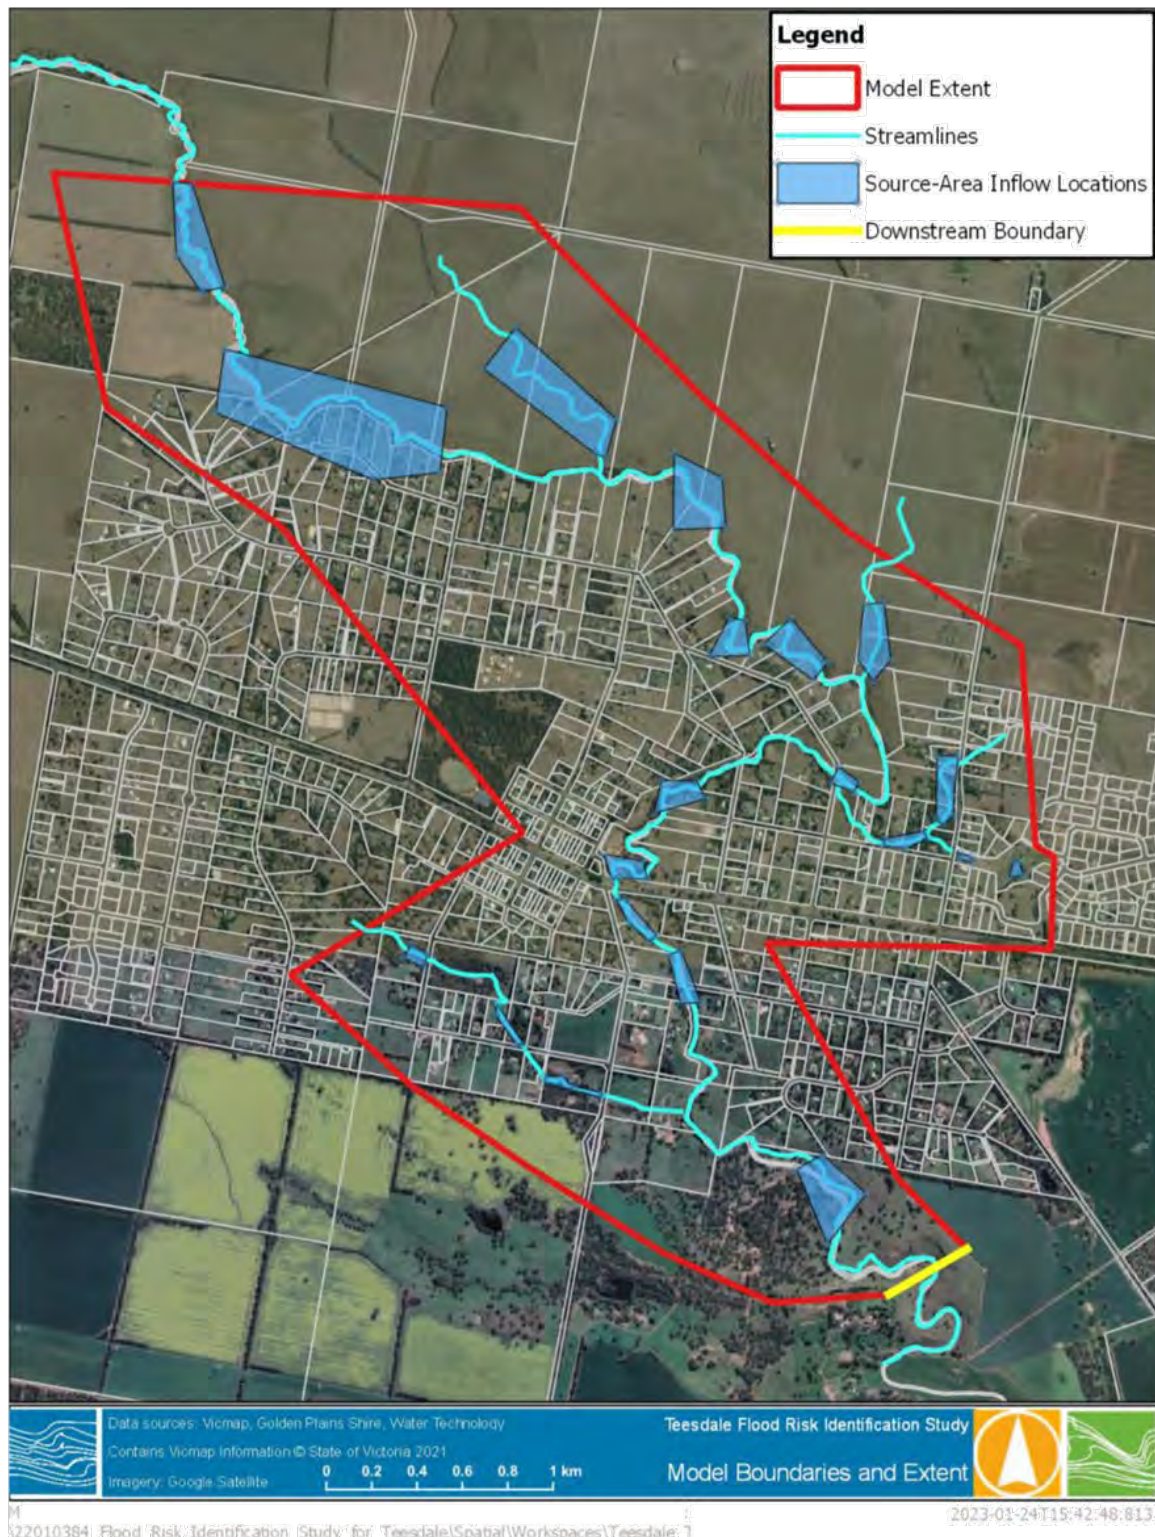
Figure 4-1 TUFLOW Extent and Model Boundaries

The model extent and boundary locations are shown in Figure 4-1.

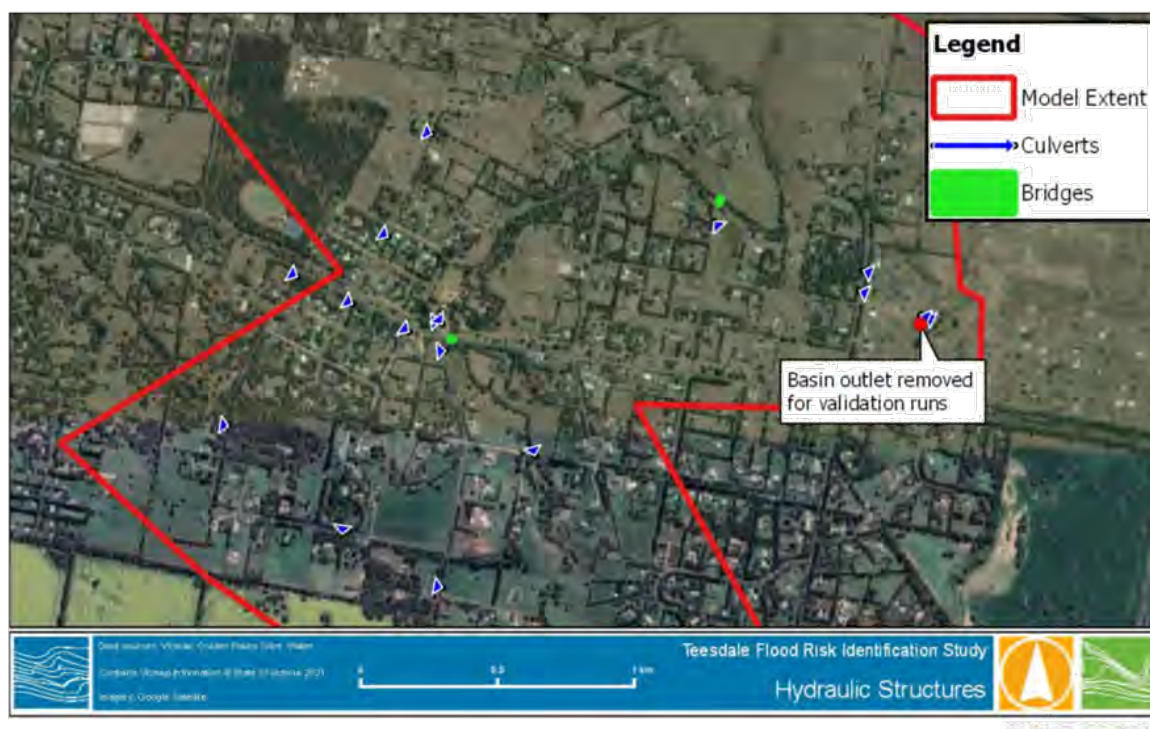
Figure 4-4 Hydraulic structures

The locations of hydraulic structures included in the model are shown in Figure 4-4 below.

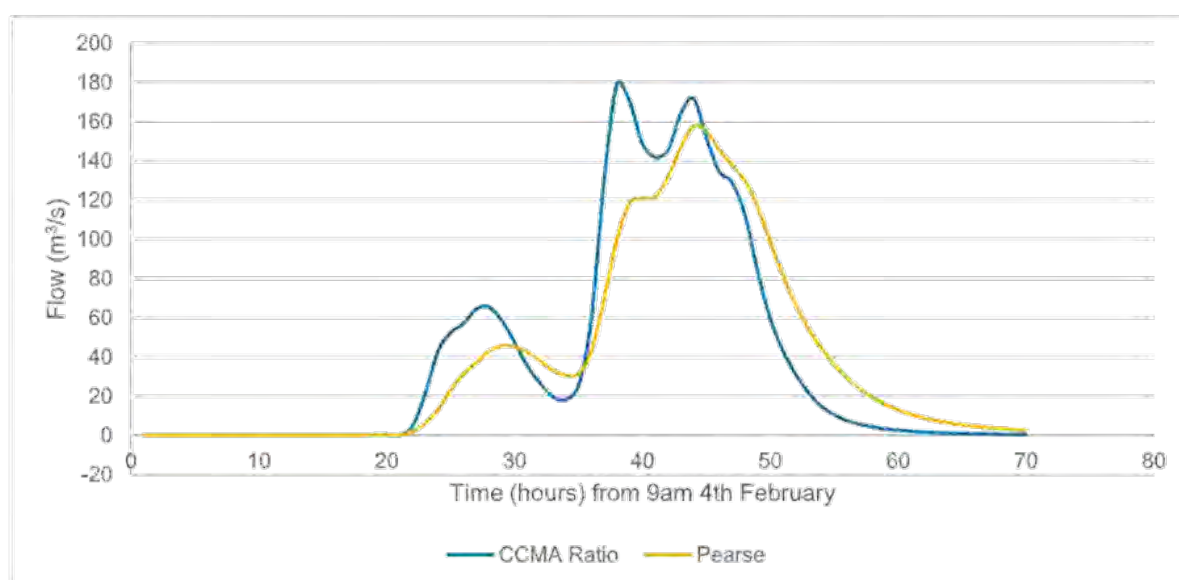
Figure 5-2 February 1973 modelled streamflow at Teesdale Bridge

Flow hydrographs extracted from the RORB model at the Bannockburn-Shelford Road bridge are shown in Figure 5-2 for the two modelled K_c values discussed in [section 2.1.5](#). The peak flow rates between the two events are similar for both k_c values with the CCMA value (18.9) producing a peak flow rate of 180 m^3/s compared to 158 m^3/s . Adopting Pearse k_c of 32.9 shows a relatively large delay in the peak timing (~8-10 hours).

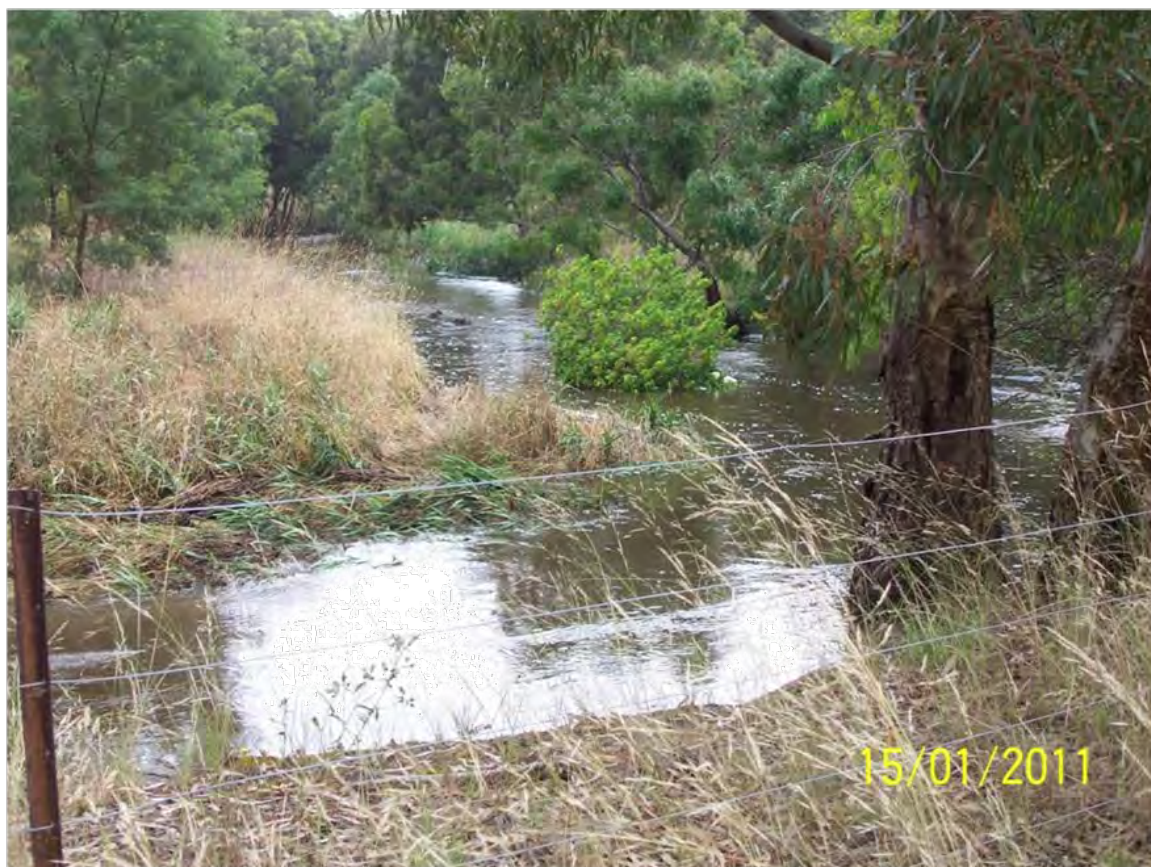
Figure 5-14 Photo provided by the residents of 75 Sutherland Street Teesdale during the 2011 flood showing flows contained within Native Hut Creek
