MOORABOOL RIVER RESERVE MASTERPLAN 2023-2033

The *Moorabool River Reserve Masterplan's* strategic basis aligns with current Victorian Government policy direction for the protection and health of the Moorabool River (Murrabul or Moorooobull Yulluk) under the Corangamite Waterway Strategy and Rivers of the Barwon (Barre Warre Yulluk) Action Plan. It also responds to the recognised values of the project area, which result from complex interactions between landscape character, biodiversity and other natural values, existing and future settlement patterns, infrastructure, Wadawurrung living cultural heritage values and historic heritage. The Moorabool River Reserve is shown in *Figure 1*.

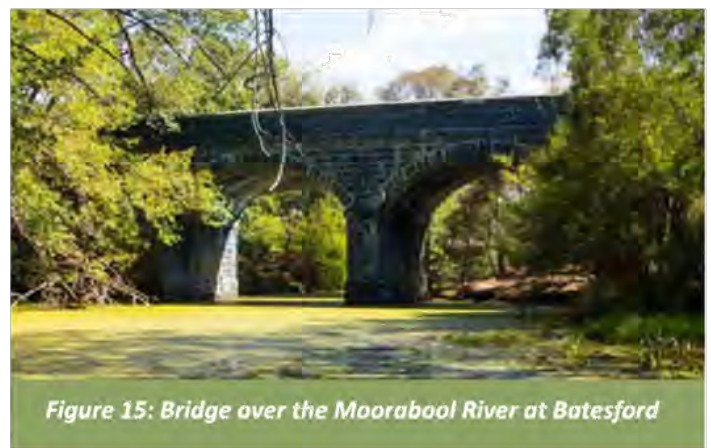
Figure 15: Bridge over the Moorabool River at Batesford

Batesford was originally the site of a ford over the Moorabool River. The first bridge at Batesford was built by the Corio and Bannockburn shire councils in 1846. This first wooden bridge, which was located upstream of the ford and provided with a tollgate, collapsed in 1847. It was rebuilt again in wood in 1848, and was damaged by flood in 1852 and later repaired. A bluestone bridge was built in 1859, which still exists today as a service road next to the Batesford Hotel. A new concrete bridge to take the Midland Highway was built in 1972 on a new alignment.

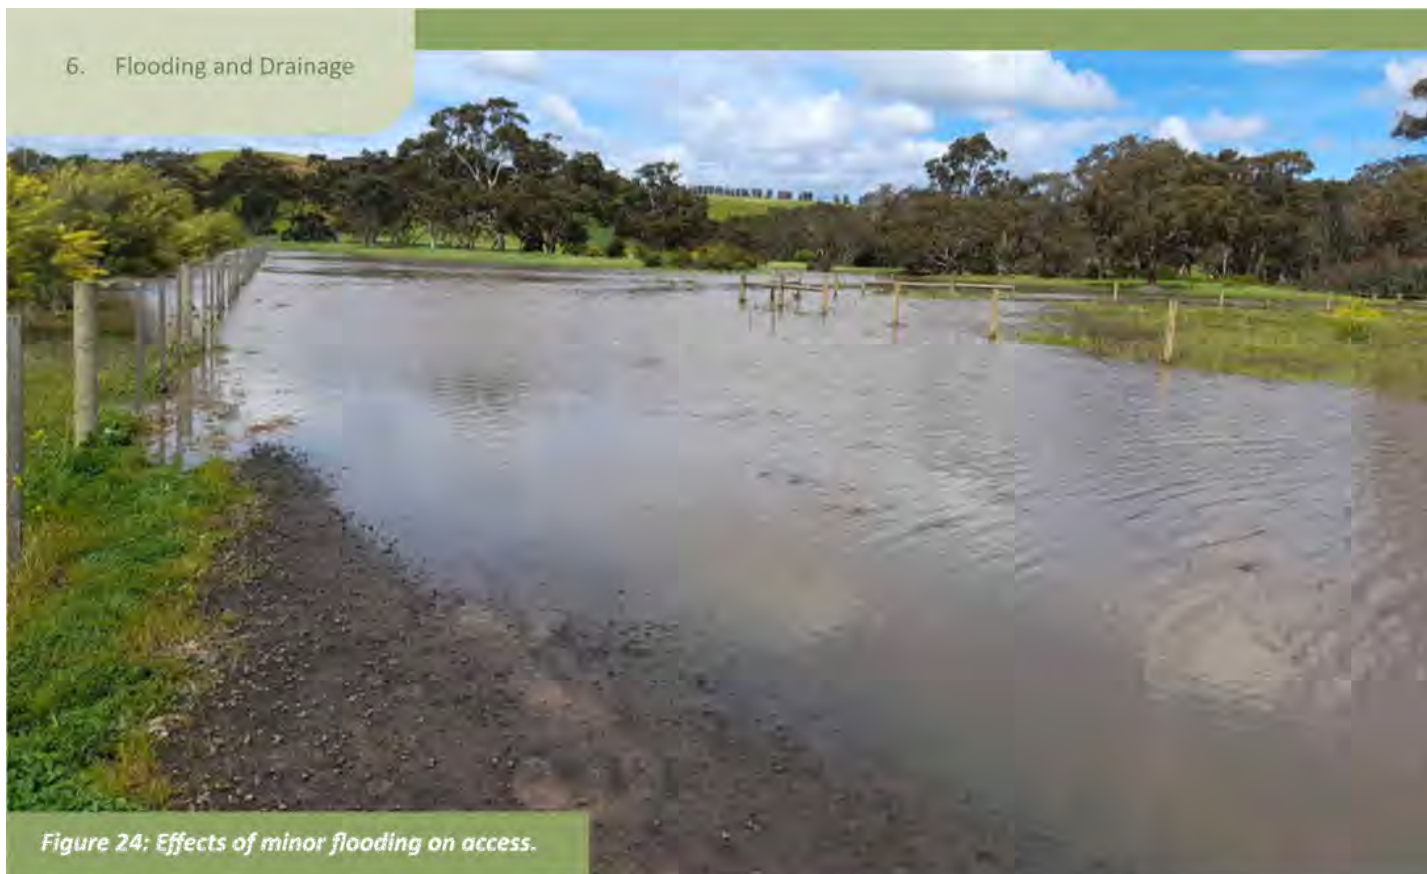
Figure 24: Effects of minor flooding on access.

Establishment of bridges or culverts over these overland flow paths is not desirable as it would allow access into the reserve during flood events making it more difficult to manage public risk and these impacts have been considered in the planned management of the Moorabool River Reserve under this Masterplan.
