# MOORABOOL RIVER RESERVE MASTERPLAN 2023-2033

# PROJECT SUMMARY

## 1. INTRODUCTION

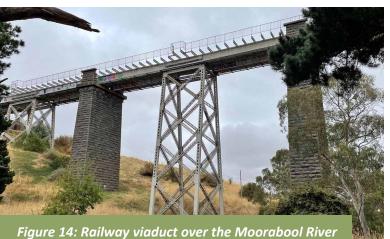
Figure 15: Bridge over the Moorabool River at Batesford

Batesford was originally the site of a ford over the Moorabool River. The first bridge at Batesford was built by the Corio and Bannockburn shire councils in 1846. This first wooden bridge, which was located upstream of the ford and provided with a tollgate, collapsed in 1847. It was rebuilt again in wood in 1848, and was damaged by flood in 1852 and later repaired. A bluestone bridge was built in 1859, which still exists today as a service road next to the Batesford Hotel. A new concrete bridge to take the Midland Highway was built in 1972 on a new alignment.

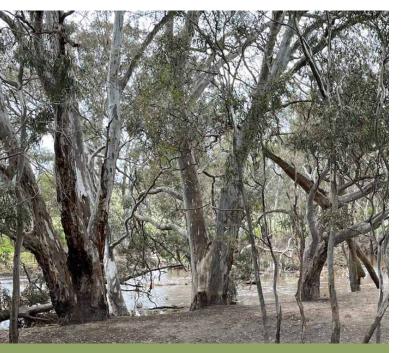
Figure 20: Southeast section of the reserve showing existing remnant overstorey vegetation.

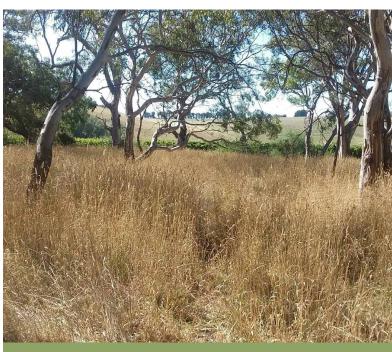
Figure 21: River Red Gum overstorey with no shrub layer and an introduced grass understorey.

However, the reserve is host to a suite of native and non-native plants. The native overstorey is dominated by River Red Gums (*E. camaldulensis*) along the watercourse and anabranches. The understorey is depauperate, but scattered remnants of the understorey shrub layer remain with Blackwood (*Acacia melanoxylon*), Tree Violet (*Melicytus dentatus*), River Bottlebrush (*Callistemon sieberi*) and Kangaroo Apple (*Solanum aviculare*) present. The ground layer is mostly non-native with most of the native grasses, sedges, herbs and forbs that would be expected to be found in this vegetation type missing.

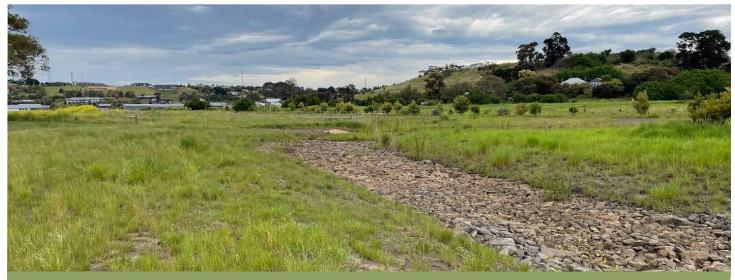
Figure 26: Clockwise from top left: mowed swale drain, stormwater retention wetland, and rocked swale drain.

A report on management of stormwater outfalls from the Riverstone development was completed in 2009 by TGM. This report indicated by adopting water sensitive urban design principles, the stormwater generated from the Riverstone Estate can be managed by a combination of mown grass swale drains, underground pipes and rock outfall structures.

1.5	Reform, deepen and revegetation of the existing rocked swale drains to improve treatment of stormwater prior to discharge into the Moorabool River.	CCMA Council Wadawurrung	Low
	<ul> <li>Excavate and slightly increase the depth of the channel at the start and end of the swale drains linking into the reserve to detain stormwater without altering the existing flow regime.</li> </ul>		
	<ul> <li>Install imported weed free topsoil and larger rock to naturalise prior to planting.</li> </ul>		
	<ul> <li>Revegetate infiltration areas with indigenous sedge and rush species into jute mat and maintain the remaining sections as mown grass.</li> </ul>
